# Access Compliance Report

## Public Rights-of-Way

### (Curb Ramps)

Intersection ID: N/A	Main Street: NORTHLAKE CENTRE PY	Cross Street: N/A	Location: NW
ADA ID: 3C93649AEEAE	Ramp Type: PerpDiag	Initial Pass/Fail: Fail	Overall Compliance: No
		Severity Score: 25

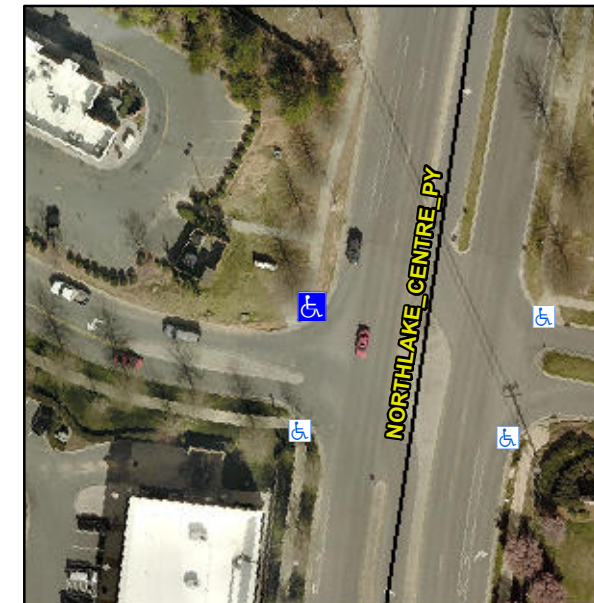
**Not Found, R304.2.2, R304.5.3**

Compliance	Description	Data	Compliance	Description	Data
N/A	Ramp Length (in)	77.0	No	Ramp Slope (%)	8.6
Yes	Ramp Width (in)	56.0	No	Ramp XSlope (%)	5.8
N/A	Flare Type LT	N/A	N/A	Flare Type RT	N/A
N/A	Flare Slope LT (%)	N/A	N/A	Flare Slope RT (%)	N/A
N/A	Flare Traversable LT?	No	N/A	Flare Traversable RT?	No
N/A	Landing Length (in)	N/A	N/A	DWS Provided?	N/A
N/A	Landing Width (in)	N/A	N/A	DWS Contrast?	N/A
N/A	Landing Slope (%)	N/A	N/A	DWS Length (in)	N/A
N/A	Landing X Slope (%)	N/A	N/A	DWS Full Width?	N/A
N/A	Landing Curb? (Y/N)	N/A	N/A	DWS Offset (in)	N/A
N/A	Shared Landing?	N/A			
N/A	Gutter Ponding?	N/A	N/A	Gutter Slope (%)	N/A
N/A	Gutter Lip Ht (in)	N/A	N/A	Gutter X Slope (%)	N/A
N/A	Painted X Walk1?	No	N/A	Painted X Walk2?	No
	X Walk 1 Direction	To S		X Walk 2 Direction	To E
N/A	X Walk 1 Width (in)	N/A	N/A	X Walk 2 Width (in)	N/A
	X Walk 1 Slope (%)	1.3		X Walk 2 Slope (%)	2.6
	X Walk 1 X Slope (%)	2.9		X Walk 2 X Slope (%)	0.8

N/A	Ramp inside XWalk1?	N/A	N/A	Ramp inside XWalk2?	N/A
	Road Slope (%)	1.8	N/A	Clear Space?	N/A
	Road X Slope (%)	2.7	N/A	Clear Space to XWalk (in)	N/A
N/A	Any Obstructions?	N/A	N/A	Storm Grate/Utility Hazard?	N/A
	Obstruction Type			Storm Grate/Utility Type	
		N/A			N/A
			Yes	Surface Condition? (G/P)	Good

**Remove & Replace Curb Ramp With Two New Directional Ramps or Equivalent.**

Total Cost: \$ 3200.00
