Access Compliance Report Public Rights-of-Way (Curb Ramps)

Intersection ID: 13522Main Street:MCCLINTOCK_RDCross Street:WESTOVER_STLocation:NWADA ID: 3C9F0A12B61BRamp Type:PerpDiagInitial Pass/Fail:PassOverall Compliance:NoSeverity Score:2.5

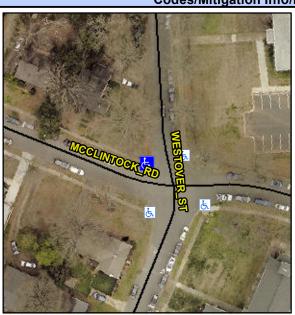
Field Measurements/Component Compilance					
Compliance Description		Data	Compliance Description		Data
N/A	Ramp Length (in)	59.0	Yes	Ramp Slope (%)	6.5
Yes	Ramp Width (in)	96.0	Yes	Ramp XSlope (%)	0.9
N/A	Flare Type LT	Sloped	N/A	Flare Type RT	N/A
N/A	Flare Slope LT (%)	2.8	N/A	Flare Slope RT (%)	1.3
N/A	Flare Traversable LT?	No	N/A	Flare Traversable RT?	No
Yes	Landing Length (in)	48.0	Yes	DWS Provided?	Yes
Yes	Landing Width (in)	48.0	Yes	DWS Contrast?	Yes
No	Landing Slope (%)	2.2	Yes	DWS Length (in)	24.0
No	Landing X Slope (%)	3.3	No	DWS Full Width?	No
N/A	Landing Curb? (Y/N)	No	No	DWS Offset (in)	9.0
N/A	Shared Landing?	No			
No	Gutter Ponding?	Yes	Yes	Gutter Slope (%)	1.3
Yes	Gutter Lip Ht (in)	0.0	Yes	Gutter X Slope (%)	0.5
N/A	Painted X Walk1?	No	N/A	Painted X Walk2?	No
	X Walk 1 Direction	To S		X Walk 2 Direction	To E
N/A	X Walk 1 Width (in)	N/A	N/A	X Walk 2 Width (in)	N/A
	X Walk 1 Slope (%)	0.9		X Walk 2 Slope (%)	0.1

X Walk 1 X Slope (%)	0.8		X Walk 2 X Slope (%)	1.9
N/A	Ramp inside XWalk1?	N/A	N/A	Ramp inside XWalk2?	N/A
	Road Slope (%)	2.3	N/A	Clear Space?	Yes
	Road X Slope (%)	0.0	N/A	Clear Space to XWalk (in)	N/A
Yes	Any Obstructions?	No	Yes	Storm Grate/Utility Hazard?	No
	Obstruction Type			Storm Grate/Utility Type	
		N/A			N/A
			Yes	Surface Condition? (G/P)	Good

WESTOVER ST StopSign MCCLINTOCK RD None Possible Solutions:

Remove & Replace Curb Ramp With Two New Directional Ramps or Equivalent. Gutter Ponding Observed.

R304.2.2-Perp, R304.3.2-Para, R304.5.3, R305.1.4, R305.2, R302.7
