# Access Compliance Report

## Public Rights-of-Way

### (Curb Ramps)

Intersection ID: 21804	Main Street: NOLLEY_CT	Cross Street: GALLERIA_BV	Location: SW
ADA ID: 3CA41AB5EF64	Ramp Type: Perp	Initial Pass/Fail: Fail	Overall Compliance: No
Severity Score: 21.25			
Codes/Mitigation Info/Possible Solution		Field Measurements/Component Compliance

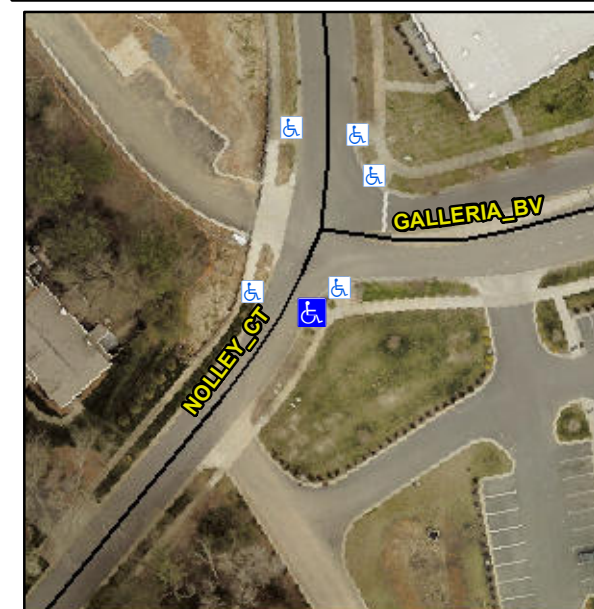
**Not Found, R304.5.1, R304.2.2**

Compliance	Description	Data	Compliance	Description	Data
N/A	Ramp Length (in)	90.0	No	Ramp Slope (%)	8.7
No	Ramp Width (in)	47.3	Yes	Ramp XSlope (%)	1.7
N/A	Flare Type LT	N/A	N/A	Flare Type RT	N/A
N/A	Flare Slope LT (%)	N/A	N/A	Flare Slope RT (%)	N/A
N/A	Flare Traversable LT?	N/A	N/A	Flare Traversable RT?	N/A
N/A	Landing Length (in)	N/A	N/A	DWS Provided?	N/A
N/A	Landing Width (in)	N/A	N/A	DWS Contrast?	N/A
N/A	Landing Slope (%)	N/A	N/A	DWS Length (in)	N/A
N/A	Landing X Slope (%)	N/A	N/A	DWS Full Width?	N/A
N/A	Landing Curb? (Y/N)	N/A	N/A	DWS Offset (in)	N/A
N/A	Shared Landing?	N/A			
N/A	Gutter Ponding?	N/A	N/A	Gutter Slope (%)	N/A
N/A	Gutter Lip Ht (in)	N/A	N/A	Gutter X Slope (%)	N/A
N/A	Painted X Walk1?	No	N/A	Painted X Walk2?	N/A
	X Walk 1 Direction	To NW		X Walk 2 Direction	N/A
N/A	X Walk 1 Width (in)	N/A	N/A	X Walk 2 Width (in)	N/A
	X Walk 1 Slope (%)	6.7		X Walk 2 Slope (%)	N/A
	X Walk 1 X Slope (%)	0.2		X Walk 2 X Slope (%)	N/A

N/A	Ramp inside XWalk1?	N/A	N/A	Ramp inside XWalk2?	N/A
	Road Slope (%)	N/A	N/A	Clear Space?	N/A
	Road X Slope (%)	N/A	N/A	Clear Space to XWalk (in)	N/A
N/A	Any Obstructions?	N/A	N/A	Storm Grate/Utility Hazard?	N/A
	Obstruction Type			Storm Grate/Utility Type	
		N/A			N/A
			Yes	Surface Condition? (G/P)	Good

**Remove & Replace Entire Ramp.**
