# Access Compliance Report

## Public Rights-of-Way

### (Curb Ramps)

Intersection ID: 53804	Main Street: NATHAN_DR	Cross Street: PITZER_DR	Location: SW
ADA ID: 3CAA521E02B9	Ramp Type: Perp	Initial Pass/Fail: Fail	Overall Compliance: No
		Severity Score: 25

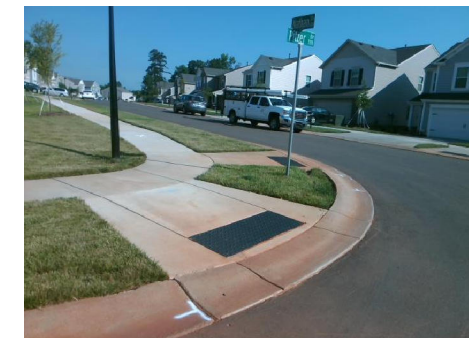
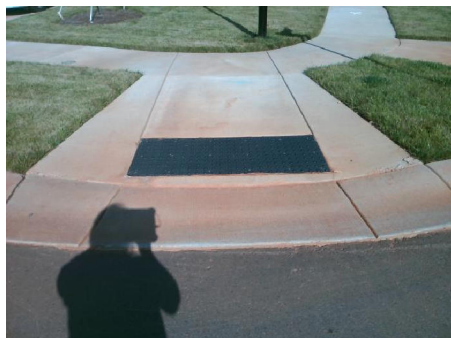
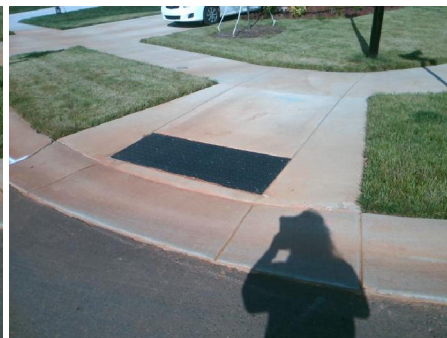
**Not Found, R304.2.2**

Compliance	Description	Data	Compliance	Description	Data
N/A	Ramp Length (in)	97.0	No	Ramp Slope (%)	12.4
Yes	Ramp Width (in)	58.0	Yes	Ramp XSlope (%)	1.5
N/A	Flare Type LT	N/A	N/A	Flare Type RT	N/A
N/A	Flare Slope LT (%)	N/A	N/A	Flare Slope RT (%)	N/A
N/A	Flare Traversable LT?	N/A	N/A	Flare Traversable RT?	N/A
N/A	Landing Length (in)	N/A	N/A	DWS Provided?	N/A
N/A	Landing Width (in)	N/A	N/A	DWS Contrast?	N/A
N/A	Landing Slope (%)	N/A	N/A	DWS Length (in)	N/A
N/A	Landing X Slope (%)	N/A	N/A	DWS Full Width?	N/A
N/A	Landing Curb? (Y/N)	N/A	N/A	DWS Offset (in)	N/A
N/A	Shared Landing?	N/A			
N/A	Gutter Ponding?	N/A	N/A	Gutter Slope (%)	N/A
N/A	Gutter Lip Ht (in)	N/A	N/A	Gutter X Slope (%)	N/A
N/A	Painted X Walk1?	No	N/A	Painted X Walk2?	N/A
	X Walk 1 Direction	To SE		X Walk 2 Direction	N/A
N/A	X Walk 1 Width (in)	N/A	N/A	X Walk 2 Width (in)	N/A
	X Walk 1 Slope (%)	1.1		X Walk 2 Slope (%)	N/A
	X Walk 1 X Slope (%)	0.2		X Walk 2 X Slope (%)	N/A

**Remove & Replace Entire Ramp.**
