Access Compliance Report

(Curb Ramps)

Intersection ID: 16868	Main Street: HASTINGS_DR	Cross Street: QUEENS_RD_WEST	Location: NE
ADA ID: 3CABC886E4E4	Ramp Type: BlendTrans1	Initial Pass/Fail: Fail	Overall Compliance: No
		Severity Score: 12.5

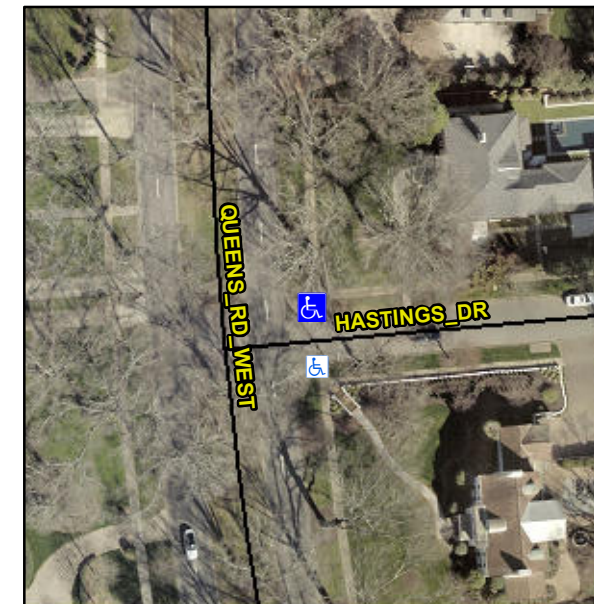
ASP LIP 1.0

R304.5.3

Compliance	Description	Data	Compliance	Description	Data
N/A	Ramp Length (in)	36.0	Yes	BlendTrans Slope (%)	4.6
Yes	Ramp Width (in)	60.0	No	BlendTrans XSlope (%)	5.7
N/A	Flare Type LT	N/A	N/A	Flare Type RT	N/A
N/A	Flare Slope LT (%)	N/A	N/A	Flare Slope RT (%)	N/A
N/A	Flare Traversable LT?	N/A	N/A	Flare Traversable RT?	N/A
N/A	Landing Length (in)	N/A	N/A	DWS Provided?	N/A
N/A	Landing Width (in)	N/A	N/A	DWS Contrast?	N/A
N/A	Landing Slope (%)	N/A	N/A	DWS Length (in)	N/A
N/A	Landing X Slope (%)	N/A	N/A	DWS Full Width?	N/A
N/A	Landing Curb? (Y/N)	N/A	N/A	DWS Offset (in)	N/A
N/A	Shared Landing?	N/A			
N/A	Gutter Ponding?	N/A	N/A	Gutter Slope (%)	N/A
N/A	Gutter Lip Ht (in)	N/A	N/A	Gutter X Slope (%)	N/A
N/A	Painted X Walk1?	No	N/A	Painted X Walk2?	N/A
	X Walk 1 Direction	To S		X Walk 2 Direction	N/A
	X Walk 1 Width (in)	N/A		X Walk 2 Width (in)	N/A
	X Walk 1 Slope (%)	4.9		X Walk 2 Slope (%)	N/A
	X Walk 1 X Slope (%)	4.3		X Walk 2 X Slope (%)	N/A

Remove & Replace Curb Ramp With Two New Directional Ramps or Equivalent.
