Access Compliance Report

Public Rights-of-Way

(Curb Ramps)

Intersection ID: 10020446	Main Street: BALTIMORE_AV	Cross Street: N/A	Location: S
ADA ID: 3CB0CCA66EE6	Ramp Type: PerpDiag	Initial Pass/Fail: Fail	Overall Compliance: No
			Severity Score: 26.25

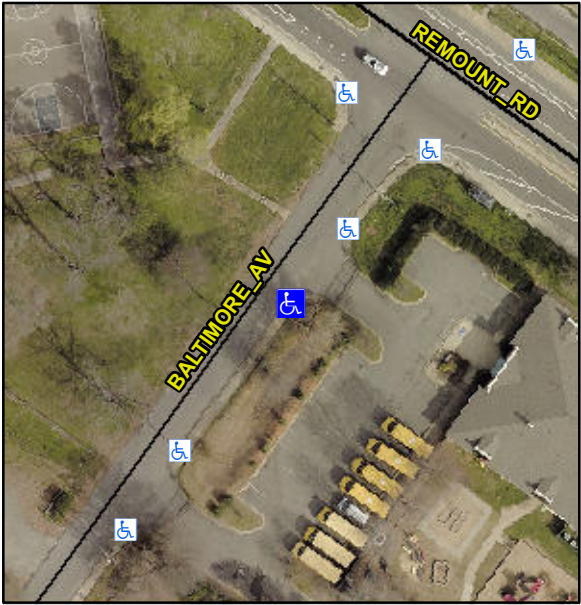
Possible Solutions:		Compliance	Description	Data
	Remove & Replace Curb Ramp With Two New Directional Ramps or Equivalent.		No	Ramp Length (in)	31.0
			Yes	Ramp Width (in)	48.0
			N/A	Flare Type LT	N/A
			N/A	Flare Slope LT (%)	N/A
			N/A	Flare Traversable LT?	N/A
			N/A	Landing Length (in)	N/A
			N/A	Landing Width (in)	N/A
			N/A	Landing Slope (%)	N/A
			N/A	Landing X Slope (%)	N/A
			N/A	Landing Curb? (Y/N)	N/A
			N/A	Shared Landing?	N/A
			N/A	Gutter Ponding?	N/A
			N/A	Gutter Lip Ht (in)	N/A
			No	Painted X Walk1?	N/A
				X Walk 1 Direction	To NE
			N/A	X Walk 1 Width (in)	N/A
				X Walk 1 Slope (%)	7.0
				X Walk 1 X Slope (%)	7.2
			N/A	Ramp inside XWalk1?	N/A
<p>Surveyor Notes:</p> <p>N/A</p> <p>PROW/ADA:</p> <p>Not Found, R304.2.2, R304.5.3</p>			N/A	Flare Type RT	N/A
			N/A	Flare Slope RT (%)	N/A
			N/A	Flare Traversable RT?	N/A
