Access Compliance Report

Public Rights-of-Way (Curb Ramps)

| Intersection ID: 10289 | | Main Street: COMMERCIAL_AV | | Cross Street: EASTWAY_DR | | Location: NW | | | | | | | | | | | | | |
| ADA ID: 3CB20445FBF0 | | Ramp Type: Directional1 | | Initial Pass/Fail: Fail | | Overall Compliance: No | | Severity Score: 1.25 | | | | | | | | | | | |

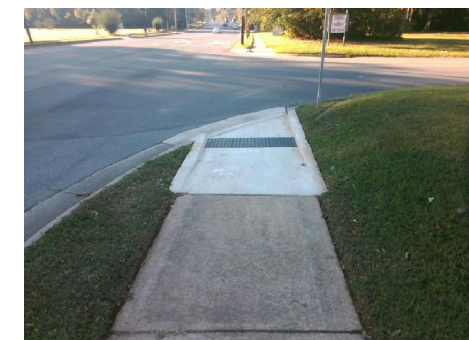
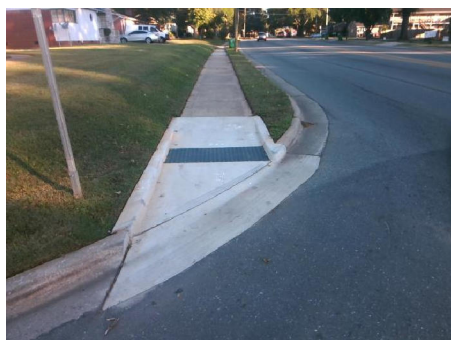
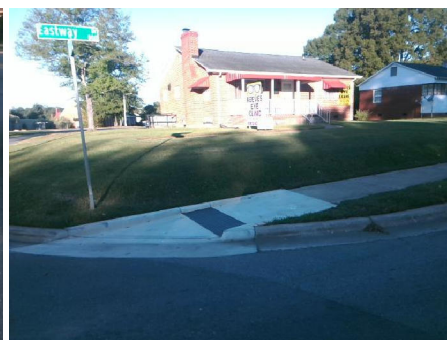
| | | | | | | No | | Ramp XSlope (%) | | 2.4 | | | | | | | | | |

| | | | | Remove & Replace Entire Ramp. | | N/A | | Ramp Length (in) | | 72.5 | | N/A | | Grade Break? | | N/A | | N/A | |
