Intersection ID: 30342	Main Street: GOLD_PAN_RD	Cross Street: SANDBOAR_ST	Location:	NE
ADA ID: 3CBF70B9B87D	Ramp Type: PerpDiag	Initial Pass/Fail: Fail	Overall Compliance: No	Severity Score: 10

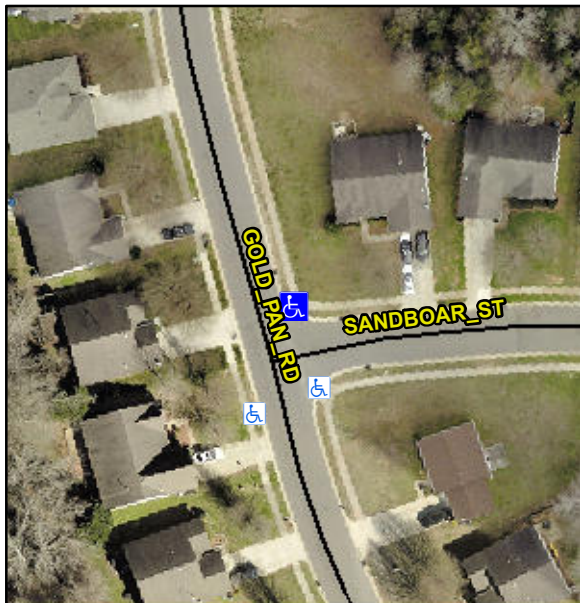
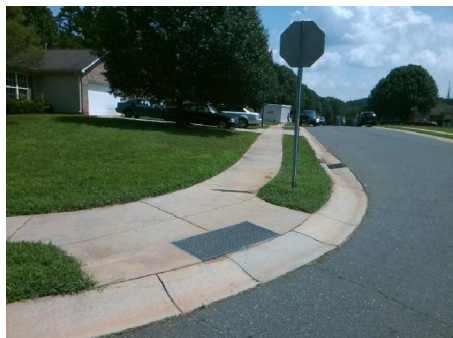
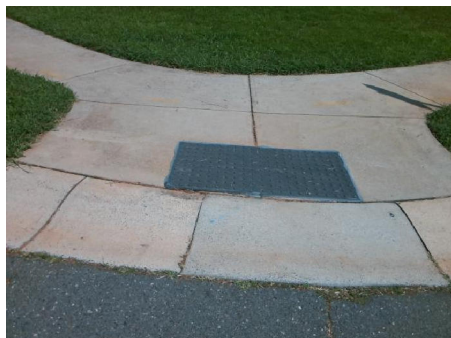
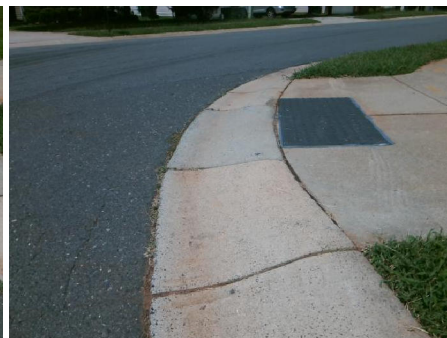
Possible Solutions:		Compliance	Description	Data	Compliance	Description	Data
	Remove & Replace Curb Ramp With Two New Directional Ramps or Equivalent.		N/A	Ramp Length (in)	50.0	Yes	Ramp Slope (%)	5.2
			No	Ramp Width (in)	47.5	No	Ramp XSlope (%)	2.8
			N/A	Flare Type LT	N/A	N/A	Flare Type RT	N/A
			N/A	Flare Slope LT (%)	N/A	N/A	Flare Slope RT (%)	N/A
			N/A	Flare Traversable LT?	N/A	N/A	Flare Traversable RT?	N/A
			N/A	Landing Length (in)	N/A	N/A	DWS Provided?	N/A
			N/A	Landing Width (in)	N/A	N/A	DWS Contrast?	N/A
			N/A	Landing Slope (%)	N/A	N/A	DWS Length (in)	N/A
			N/A	Landing X Slope (%)	N/A	N/A	DWS Full Width?	N/A
Street 1 Name	Surveyor Notes:		N/A	Landing Curb? (Y/N)	N/A	N/A	DWS Offset (in)	N/A
	N/A		N/A	Shared Landing?	N/A			
	PROW/ADA:		N/A	Gutter Ponding?	N/A	N/A	Gutter Slope (%)	N/A
	Not Found, R304.5.1, R304.5.3		N/A	Gutter Lip Ht (in)	N/A	N/A	Gutter X Slope (%)	N/A

N/A	Painted X Walk1?	No	N/A	Painted X Walk2?	No
				X Walk 1 Direction	To W		X Walk 2 Direction	To S
			N/A	X Walk 1 Width (in)	N/A	N/A	X Walk 2 Width (in)	N/A
				X Walk 1 Slope (%)	0.9		X Walk 2 Slope (%)	1.1
				X Walk 1 X Slope (%)	0.2		X Walk 2 X Slope (%)	1.7
			N/A	Ramp inside XWalk1?	N/A	N/A	Ramp inside XWalk2?	N/A
Stop Condition-Street 2		Road Slope (%)		0.7	N/A	Clear Space?	N/A	
Street 2 Name		Road X Slope (%)		2.4	N/A	Clear Space to XWalk (in)	N/A	
Stop Condition-Street 1		Any Obstructions?		N/A	N/A	Storm Grate/Utility Hazard?	N/A	
		Obstruction Type				Storm Grate/Utility Type		
				N/A			N/A	
					Yes	Surface Condition? (G/P)	Good	
Total Cost:		\$	3200.00
