# Access Compliance Report

## Public Rights-of-Way

### (Curb Ramps)

Intersection ID: 52911	Main Street: CLEMS_CREEK_LN	Cross Street: CLEMS_CROSSING_DR	Location: NE
ADA ID: 3CBF81A592F6	Ramp Type: Directional1	Initial Pass/Fail: Fail	Overall Compliance: No
		Severity Score: 1.25

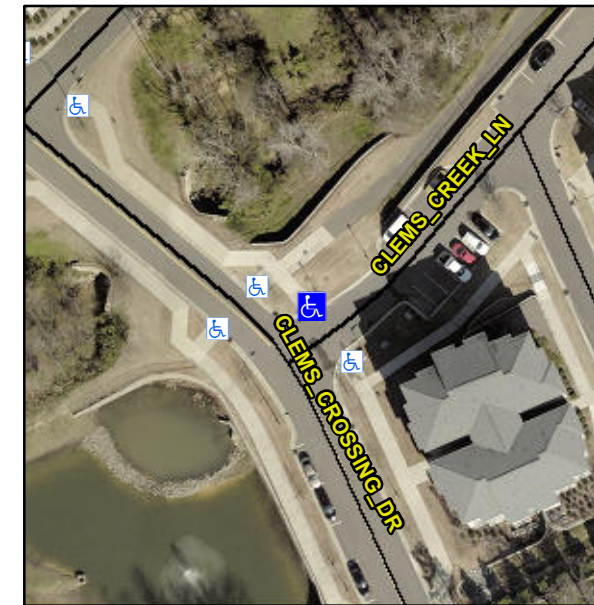
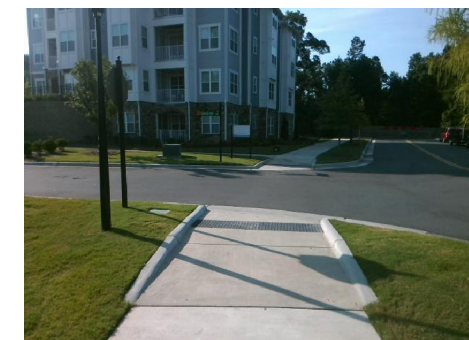
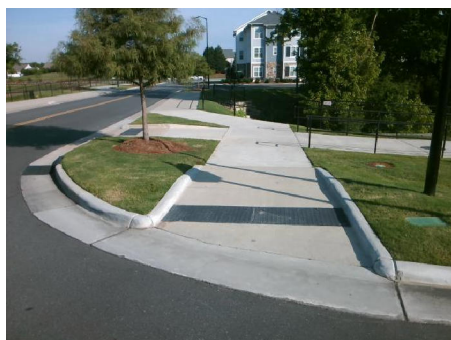
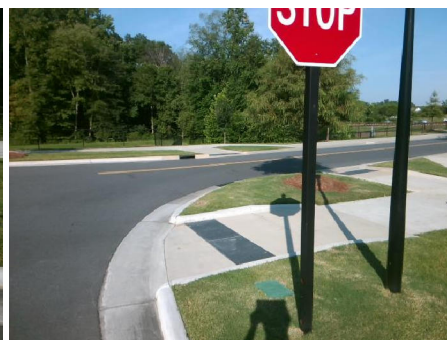
Compliance	Description	Data	Compliance	Description	Data
N/A	Ramp Length (in)	140.0	N/A	Grade Break?	N/A
Yes	Ramp Width (in)	94.0	N/A	Grade Break Slope (%)	0.0
Yes	Ramp Slope (%)	1.3	N/A	Grade Break XSlope (%)	0.0
No	Ramp XSlope (%)	2.3			
N/A	Flare Type LT	N/A	N/A	Flare Type RT	N/A
N/A	Flare Slope LT (%)	N/A	N/A	Flare Slope RT (%)	0.0
N/A	Flare Traversable LT?	N/A	N/A	Flare Traversable RT?	N/A
N/A	Landing Length (in)	0.0	N/A	DWS Provided?	N/A
N/A	Landing Width (in)	0.0	N/A	DWS Contrast?	N/A
N/A	Landing Slope (%)	0.0	N/A	DWS Length (in)	N/A
N/A	Landing X Slope (%)	0.0	N/A	DWS Full Width?	N/A
N/A	Landing Curb? (Y/N)	N/A	N/A	DWS Offset LT (in)	N/A
N/A	Shared Landing?	N/A	N/A	DWS Offset RT (in)	N/A
N/A	Gutter Ponding?	0.0	N/A	Gutter Slope (%)	N/A
N/A	Gutter Lip Ht (in)	0.0	N/A	Gutter X Slope (%)	N/A
N/A	Painted X Walk1?	No		Road Slope (%)	2.8
	X Walk 1 Direction	To SE		Road X Slope (%)	0.3
	X Walk 1 Width (in)	N/A		Clear Space?	N/A

X Walk 1 Slope (%)	2.8	N/A	Clear Space to XWalk (in)	N/A
	X Walk 1 X Slope (%)	0.3	N/A	Storm Grate/Utility Hazard?	N/A
N/A	Ramp inside XWalk1?	N/A		Storm Grate/Utility Type	
N/A	Any Obstructions?	N/A			N/A
	Obstruction Type		Yes	Surface Condition? (G/P)	Good
			N/A	Curb Slope (%)	8.4

**Remove & Replace Entire Ramp.**

**R304.5.3**

\$ 1600.00
