Access Compliance Report Public Rights-of-Way (Curb Ramps)

Intersection ID: 52530 Main Street: BAMBOO_ST **Cross Street: PIERSON_DR** Location: SE **Overall Compliance: No** ADA ID: 3CC2932C06F7 Ramp Type: Perp Initial Pass/Fail: Fail **Severity Score:** 12.5

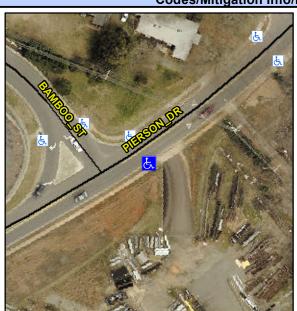
Field Measurements/Component Compliance						
Compliance Description		Data	Compli	ance Description	Data	
N/A F	Ramp Length (in)	86.0	No	Ramp Slope (%)	8.5	
Yes F	Ramp Width (in)	66.5	Yes	Ramp XSlope (%)	1.2	
N/A F	Flare Type LT	N/A	N/A	Flare Type RT	N/A	
N/A F	Flare Slope LT (%)	N/A	N/A	Flare Slope RT (%)	N/A	
N/A F	Flare Traversable LT?	N/A	N/A	Flare Traversable RT?	N/A	
N/A L	anding Length (in)	N/A	N/A	DWS Provided?	N/A	
N/A L	anding Width (in)	N/A	N/A	DWS Contrast?	N/A	
N/A L	anding Slope (%)	N/A	N/A	DWS Length (in)	N/A	
N/A L	anding X Slope (%)	N/A	N/A	DWS Full Width?	N/A	
N/A L	anding Curb? (Y/N)	N/A	N/A	DWS Offset (in)	N/A	
N/A S	Shared Landing?	N/A				
N/A	Gutter Ponding?	N/A	N/A	Gutter Slope (%)	N/A	
N/A	Gutter Lip Ht (in)	N/A	N/A	Gutter X Slope (%)	N/A	
N/A F	Painted X Walk1?	No	N/A	Painted X Walk2?	N/A	
>	Walk 1 Direction	To N		X Walk 2 Direction	N/A	
N/A	(Walk 1 Width (in)	N/A	N/A	X Walk 2 Width (in)	N/A

>	(Walk 1 Slope (%)	1.5		X Walk 2 Slope (%)	N/A	
>	(Walk 1 X Slope (%)	1.6		X Walk 2 X Slope (%)	N/A	
N/A F	Ramp inside XWalk1?	N/A	N/A	Ramp inside XWalk2?	N/A	
F	Road Slope (%)	N/A	N/A	Clear Space?	N/A	
F	Road X Slope (%)	N/A	N/A	Clear Space to XWalk (in)	N/A	
N/A	Any Obstructions?	N/A	N/A	Storm Grate/Utility Hazard?	N/A	
(Obstruction Type			Storm Grate/Utility Type		
		N/A			N/A

Possible Solutions:	9	
Remove & Replace Entire Ramp.		
	Y	
	N	
	N	
	N	
	N	
Surveyor Notes:	N	
N/A	N	
	N	
	N	
	N	
PROW/ADA:	N	
Not Found, R304.2.2		
	N	
	N
