Access Compliance Report

Public Rights-of-Way

(Curb Ramps)

Intersection ID: 3910	Main Street: HALLIWELL_ST	Cross Street: WETHERBURN_LN	Location:	E
ADA ID: 3CD3506DF4A5	Ramp Type: Perp	Initial Pass/Fail: Fail	Overall Compliance: No	Severity Score: 25

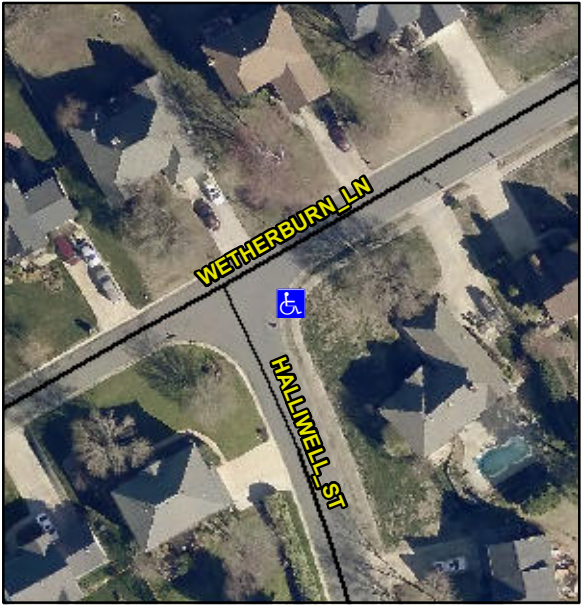
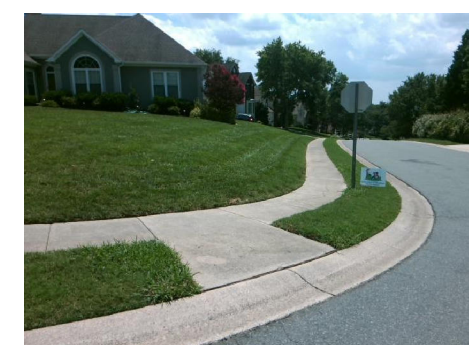
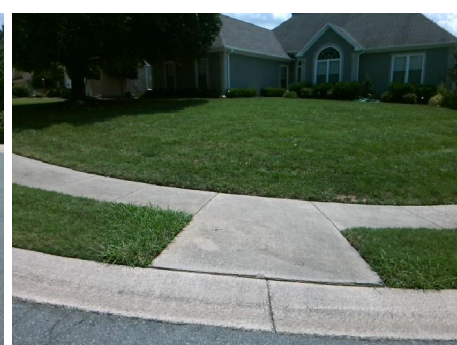
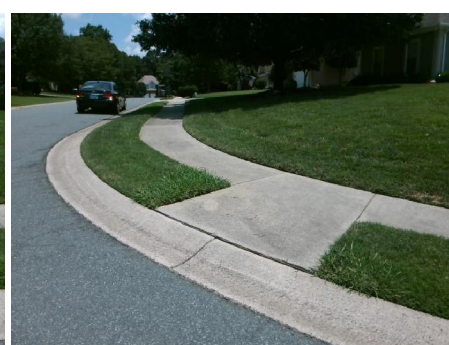
Possible Solutions:		Compliance	Description	Data
	Remove & Replace Entire Ramp.		N/A	Ramp Length (in)	97.0
			Yes	Ramp Width (in)	58.0
			N/A	Flare Type LT	N/A
			N/A	Flare Slope LT (%)	N/A
			N/A	Flare Traversable LT?	N/A
			N/A	Landing Length (in)	N/A
			N/A	Landing Width (in)	N/A
			N/A	Landing Slope (%)	N/A
			N/A	Landing X Slope (%)	N/A
<p>Surveyor Notes:</p> <p>N/A</p> <p>PROW/ADA:</p> <p>Not Found, R304.5.3</p>			N/A	Flare Type RT	N/A
			N/A	Flare Slope RT (%)	N/A
			N/A	Flare Traversable RT?	N/A
			N/A	DWS Provided?	N/A
			N/A	DWS Contrast?	N/A
			N/A	DWS Length (in)	N/A
			N/A	DWS Full Width?	N/A
			N/A	DWS Offset (in)	N/A
			N/A	Shared Landing?	N/A
			N/A	Gutter Ponding?	N/A
			N/A	Gutter Lip Ht (in)	N/A
			N/A	Painted X Walk1?	No
				X Walk 1 Direction	To SW
			N/A	X Walk 1 Width (in)	N/A
				X Walk 1 Slope (%)	2.8
				X Walk 1 X Slope (%)	2.7

N/A	Ramp inside XWalk1?	N/A
			N/A	Road Slope (%)	N/A
			N/A	Road X Slope (%)	N/A
			N/A	Any Obstructions?	N/A
				Obstruction Type	
Total Cost:		\$ 1850.00			
			N/A		N/A
			Yes	Surface Condition? (G/P)	Good
