# Access Compliance Report

## Public Rights-of-Way

### (Curb Ramps)

Intersection ID: 8910	Main Street: KAY_ST	Cross Street: NEWCASTLE_ST	Location: SW
ADA ID: 3CDD1365C15A	Ramp Type: Para	Initial Pass/Fail: Fail	Overall Compliance: No
			Severity Score: 26.25

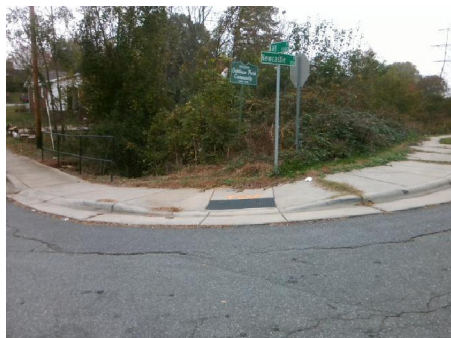
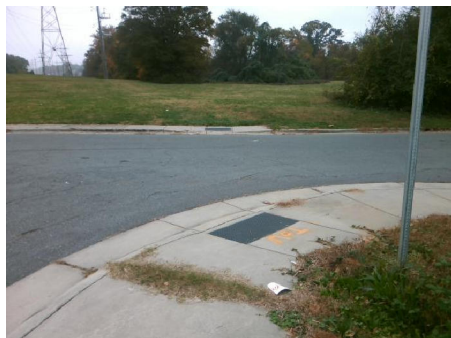
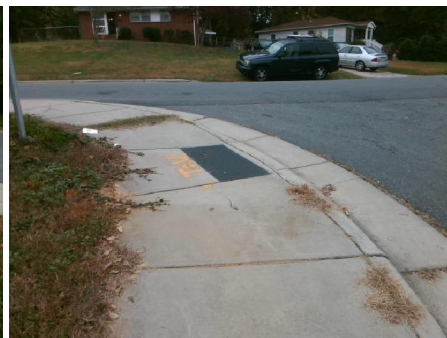
**LT RP < 5%**

Compliance	Description	Data	Compliance	Description	Data
N/A	Ramp Length LT (in)	41.5	N/A	Ramp Length RT (in)	37.0
Yes	Ramp Width LT (in)	70.0	Yes	Ramp Width RT (in)	70.0
Yes	Ramp Slope LT (%)	3.0	No	Ramp Slope RT (%)	16.5
No	Ramp XSlope LT (%)	2.6	No	Ramp XSlope RT (%)	2.9
N/A	Landing Length (in)	N/A	N/A	DWS Provided?	N/A
N/A	Landing Width (in)	N/A	N/A	DWS Contrast?	N/A
N/A	Landing Slope (%)	N/A	N/A	DWS Length (in)	N/A
N/A	Landing X Slope (%)	N/A	N/A	DWS Full Width?	N/A
N/A	Landing Curb? (Y/N)	N/A	N/A	DWS Offset (in)	N/A
N/A	Shared Landing?	N/A			
N/A	Gutter Ponding?	N/A	N/A	Gutter Slope (%)	N/A
N/A	Gutter Lip Ht (in)	1.0	N/A	Gutter X Slope (%)	N/A
N/A	Painted X Walk1?	No	N/A	Painted X Walk2?	N/A
	X Walk 1 Direction	To E		X Walk 2 Direction	N/A
N/A	X Walk 1 Width (in)	N/A	N/A	X Walk 2 Width (in)	N/A
	X Walk 1 Slope (%)	1.3		X Walk 2 Slope (%)	N/A
	X Walk 1 X Slope (%)	6.3		X Walk 2 X Slope (%)	N/A
N/A	Ramp inside XWalk1?	N/A	N/A	Ramp inside XWalk2?	N/A

Road Slope (%)	N/A	N/A	Clear Space?	N/A
	Road X Slope (%)	N/A	N/A	Clear Space to XWalk (in)	N/A
N/A	Any Obstructions?	N/A	N/A	Storm Grate/Utility Hazard?	N/A
	Obstruction Type			Storm Grate/Utility Type	
		N/A			N/A
			Yes	Surface Condition? (G/P)	Good
			N/A	Curb Slope (%)	15.3

**Remove & Replace Entire Ramp.**

**R304.5.3, R304.3.2**
