Access Compliance Report

Public Rights-of-Way

(Curb Ramps)

Intersection ID: 6326	Main Street: UNIVERSITY_CITY_BV	Cross Street: CHANCELLOR_PARK_DR	Location:	SE
ADA ID: 3CDF928D7447	Ramp Type: BlendTrans1	Initial Pass/Fail: Fail	Overall Compliance: No	Severity Score: 10

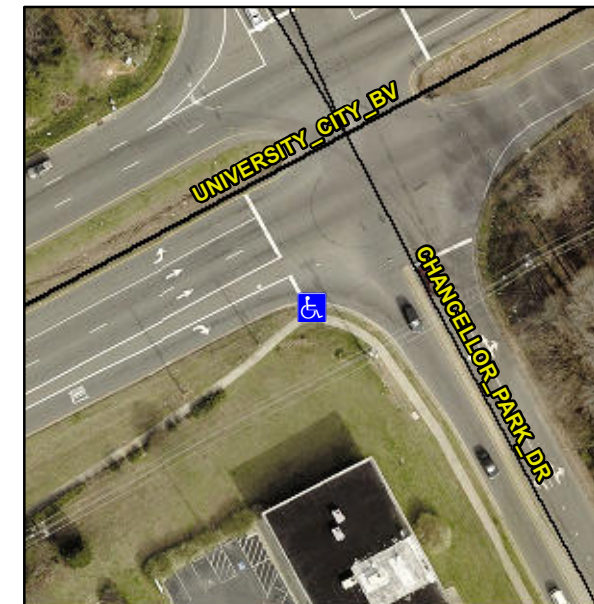
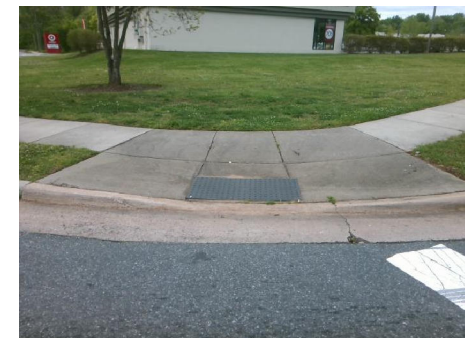
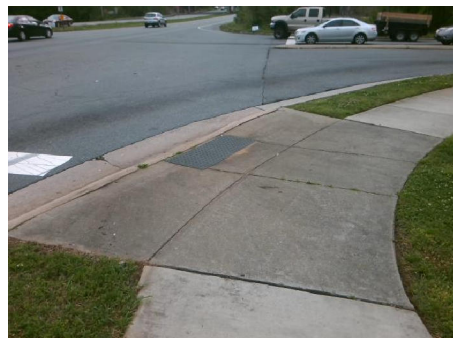
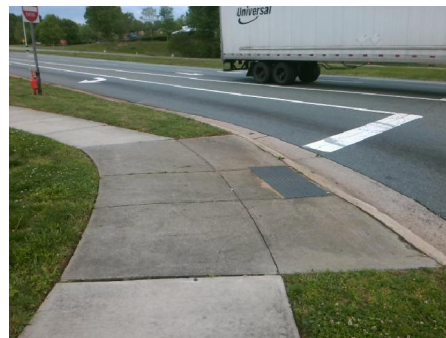
Not Found, R304.5.1, R304.5.3

Compliance	Description	Data	Compliance	Description	Data
N/A	Ramp Length (in)	46.0	Yes	BlendTrans Slope (%)	4.3
No	Ramp Width (in)	43.0	No	BlendTrans XSlope (%)	3.7
N/A	Flare Type LT	N/A	N/A	Flare Type RT	N/A
N/A	Flare Slope LT (%)	N/A	N/A	Flare Slope RT (%)	N/A
N/A	Flare Traversable LT?	N/A	N/A	Flare Traversable RT?	N/A
N/A	Landing Length (in)	N/A	N/A	DWS Provided?	N/A
N/A	Landing Width (in)	N/A	N/A	DWS Contrast?	N/A
N/A	Landing Slope (%)	N/A	N/A	DWS Length (in)	N/A
N/A	Landing X Slope (%)	N/A	N/A	DWS Full Width?	N/A
N/A	Landing Curb? (Y/N)	N/A	N/A	DWS Offset (in)	N/A
N/A	Shared Landing?	N/A			
N/A	Gutter Ponding?	N/A	N/A	Gutter Slope (%)	N/A
N/A	Gutter Lip Ht (in)	N/A	N/A	Gutter X Slope (%)	N/A
N/A	Painted X Walk1?	No	N/A	Painted X Walk2?	No
	X Walk 1 Direction	To N		X Walk 2 Direction	To E
	X Walk 1 Width (in)	N/A		X Walk 2 Width (in)	N/A
	X Walk 1 Slope (%)	2.3		X Walk 2 Slope (%)	N/A
	X Walk 1 X Slope (%)	1.9		X Walk 2 X Slope (%)	N/A

N/A	Ramp inside XWalk1?	N/A	N/A	Ramp inside XWalk2?	N/A
	Road Slope (%)	1.9		Clear Space?	N/A
	Road X Slope (%)	2.3	N/A	Clear Space to XWalk (in)	N/A
N/A	Any Obstructions?	N/A	N/A	Storm Grate/Utility Hazard?	N/A
	Obstruction Type			Storm Grate/Utility Type	
		N/A			N/A
			Yes	Surface Condition? (G/P)	Good
			No	Curb Slope (%)	12.2

Remove & Replace Curb Ramp With Two New Directional Ramps or Equivalent.

Total Cost: \$ 3200.00
