# Access Compliance Report

## Public Rights-of-Way

### (Curb Ramps)

Intersection ID: 54318	Main Street: CANTERBURY_CASTLE_DR	Cross Street: BELMONT_MANSION_DR	Location: NW
ADA ID: 3CE48D00B047	Ramp Type: BlendTrans1	Initial Pass/Fail: Fail	Overall Compliance: No
Severity Score: 12.5			
Codes/Mitigation Info/Possible Solution		Field Measurements/Component Compliance

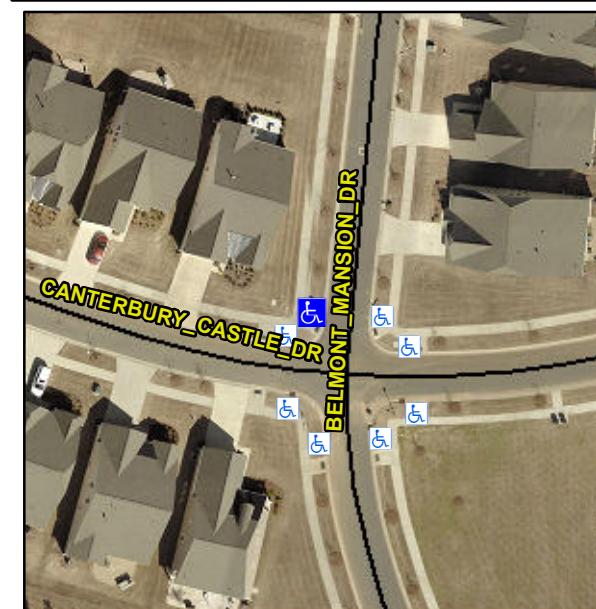
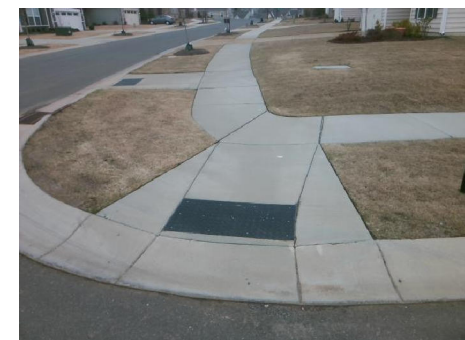
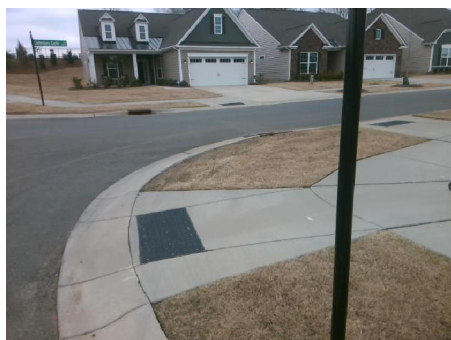
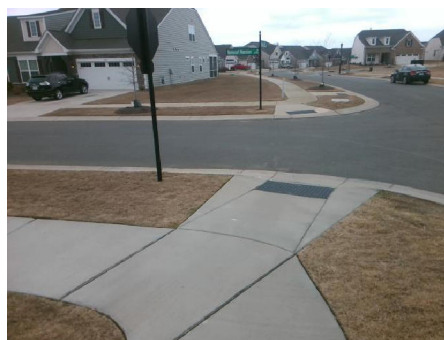
Compliance	Description	Data	Compliance	Description	Data
N/A	Ramp Length (in)	96.0	Yes	BlendTrans Slope (%)	3.8
Yes	Ramp Width (in)	48.0	No	BlendTrans XSlope (%)	6.8
N/A	Flare Type LT	N/A	N/A	Flare Type RT	N/A
N/A	Flare Slope LT (%)	N/A	N/A	Flare Slope RT (%)	N/A
N/A	Flare Traversable LT?	N/A	N/A	Flare Traversable RT?	N/A
N/A	Landing Length (in)	N/A	N/A	DWS Provided?	N/A
N/A	Landing Width (in)	N/A	N/A	DWS Contrast?	N/A
N/A	Landing Slope (%)	N/A	N/A	DWS Length (in)	N/A
N/A	Landing X Slope (%)	N/A	N/A	DWS Full Width?	N/A
N/A	Landing Curb? (Y/N)	N/A	N/A	DWS Offset (in)	N/A
N/A	Shared Landing?	N/A			
N/A	Gutter Ponding?	N/A	N/A	Gutter Slope (%)	N/A
N/A	Gutter Lip Ht (in)	1.0	N/A	Gutter X Slope (%)	N/A
N/A	Painted X Walk1?	No	N/A	Painted X Walk2?	N/A
	X Walk 1 Direction	To E		X Walk 2 Direction	N/A
	X Walk 1 Width (in)	N/A		X Walk 2 Width (in)	N/A
	X Walk 1 Slope (%)	2.7		X Walk 2 Slope (%)	N/A
	X Walk 1 X Slope (%)	2.4		X Walk 2 X Slope (%)	N/A

N/A	Ramp inside XWalk1?	N/A	N/A	Ramp inside XWalk2?	N/A
	Road Slope (%)	2.4		Clear Space?	N/A
	Road X Slope (%)	2.7	N/A	Clear Space to XWalk (in)	N/A
N/A	Any Obstructions?	N/A	N/A	Storm Grate/Utility Hazard?	N/A
	Obstruction Type			Storm Grate/Utility Type	
		N/A			N/A
			Yes	Surface Condition? (G/P)	Good
			N/A	Curb Slope (%)	2.4

Possible Solutions:

**Remove & Replace Curb Ramp With Two New Directional Ramps or Equivalent.**

**R304.5.3**

**\$ 3200.00**
