# Access Compliance Report

## Public Rights-of-Way

### (Curb Ramps)

Intersection ID: 3176	Main Street: OLD_TIMBER_RD	Cross Street: SUTTERS_HILL_CT	Location: W
ADA ID: 3CE8F1153225	Ramp Type: Perp	Initial Pass/Fail: Fail	Overall Compliance: No
Severity Score: 25			
Codes/Mitigation Info/Possible Solution		Field Measurements/Component Compliance

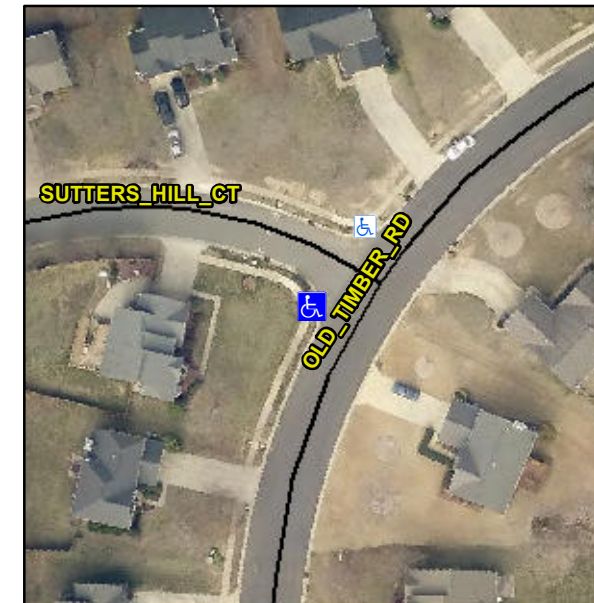
**Not Found, R304.5.3**

Compliance	Description	Data	Compliance	Description	Data
N/A	Ramp Length (in)	48.0	Yes	Ramp Slope (%)	5.7
Yes	Ramp Width (in)	52.5	No	Ramp XSlope (%)	7.7
N/A	Flare Type LT	N/A	N/A	Flare Type RT	N/A
N/A	Flare Slope LT (%)	N/A	N/A	Flare Slope RT (%)	N/A
N/A	Flare Traversable LT?	N/A	N/A	Flare Traversable RT?	N/A
N/A	Landing Length (in)	N/A	N/A	DWS Provided?	N/A
N/A	Landing Width (in)	N/A	N/A	DWS Contrast?	N/A
N/A	Landing Slope (%)	N/A	N/A	DWS Length (in)	N/A
N/A	Landing X Slope (%)	N/A	N/A	DWS Full Width?	N/A
N/A	Landing Curb? (Y/N)	N/A	N/A	DWS Offset (in)	N/A
N/A	Shared Landing?	N/A			
N/A	Gutter Ponding?	N/A	N/A	Gutter Slope (%)	N/A
N/A	Gutter Lip Ht (in)	N/A	N/A	Gutter X Slope (%)	N/A
N/A	Painted X Walk1?	No	N/A	Painted X Walk2?	N/A
	X Walk 1 Direction	To NE		X Walk 2 Direction	N/A
N/A	X Walk 1 Width (in)	N/A	N/A	X Walk 2 Width (in)	N/A
	X Walk 1 Slope (%)	7.5		X Walk 2 Slope (%)	N/A
	X Walk 1 X Slope (%)	1.7		X Walk 2 X Slope (%)	N/A

N/A	Ramp inside XWalk1?	N/A	N/A	Ramp inside XWalk2?	N/A
	Road Slope (%)	N/A	N/A	Clear Space?	N/A
	Road X Slope (%)	N/A	N/A	Clear Space to XWalk (in)	N/A
N/A	Any Obstructions?	N/A	N/A	Storm Grate/Utility Hazard?	N/A
	Obstruction Type			Storm Grate/Utility Type	
		N/A			N/A
		Yes		Surface Condition? (G/P)	Good

**Remove & Replace Entire Ramp.**

Total Cost: \$ 1850.00
