Access Compliance Report

Public Rights-of-Way

(Curb Ramps)

Intersection ID: 46144	Main Street: EASTFIELD_VILLAGE_LN	Cross Street: ROCKY_FORD_CLUB_RD	Location: S
ADA ID: 3CF91BFD35FF	Ramp Type: Perp	Initial Pass/Fail: Pass	Overall Compliance: No
Severity Score: 0.25			
Codes/Mitigation Info/Possible Solution		Field Measurements/Component Compliance

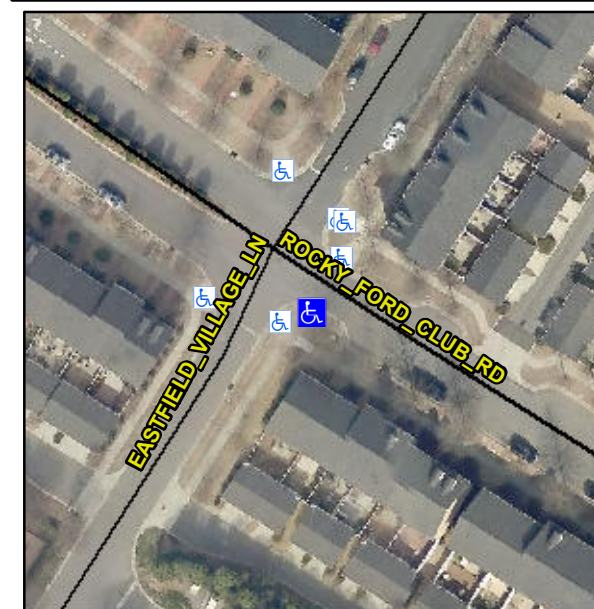
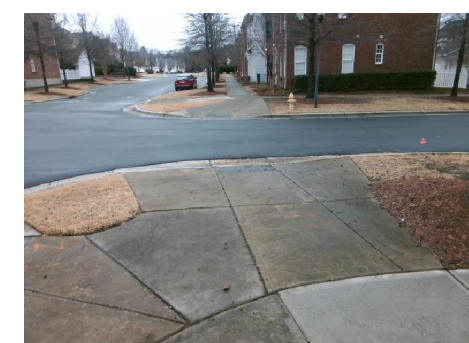
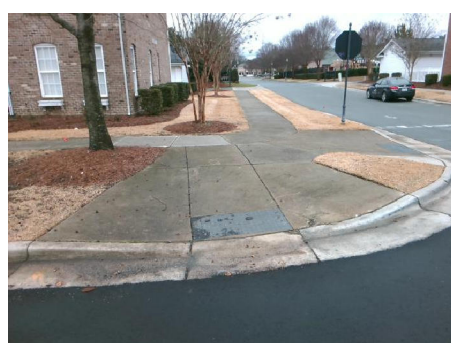
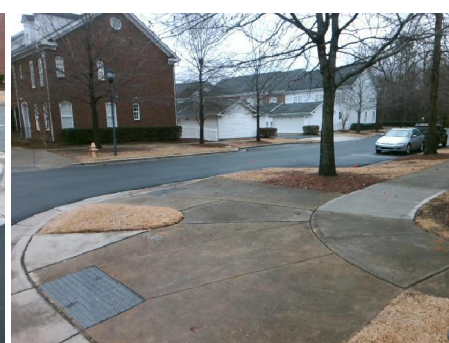
Compliance	Description	Data	Compliance	Description	Data
N/A	Ramp Length (in)	187.0	Yes	Ramp Slope (%)	6.5
Yes	Ramp Width (in)	48.0	Yes	Ramp XSlope (%)	2.8
N/A	Flare Type LT	Sloped	N/A	Flare Type RT	N/A
N/A	Flare Slope LT (%)	7.1	Yes	Flare Slope RT (%)	8.9
N/A	Flare Traversable LT?	Yes	N/A	Flare Traversable RT?	Yes
Yes	Landing Length (in)	60.0	Yes	DWS Provided?	Yes
No	Landing Width (in)	46.0	Yes	DWS Contrast?	Yes
Yes	Landing Slope (%)	0.0	Yes	DWS Length (in)	24.0
Yes	Landing X Slope (%)	0.5	Yes	DWS Full Width?	Yes
N/A	Landing Curb? (Y/N)	No	Yes	DWS Offset (in)	2.0
N/A	Shared Landing?	No			
Yes	Gutter Ponding?	No	Yes	Gutter Slope (%)	2.6
Yes	Gutter Lip Ht (in)	0.0	Yes	Gutter X Slope (%)	2.8
N/A	Painted X Walk1?	No	N/A	Painted X Walk2?	N/A
	X Walk 1 Direction	To NE		X Walk 2 Direction	N/A
N/A	X Walk 1 Width (in)	N/A	N/A	X Walk 2 Width (in)	N/A
	X Walk 1 Slope (%)	4.6		X Walk 2 Slope (%)	N/A
	X Walk 1 X Slope (%)	2.8		X Walk 2 X Slope (%)	N/A

N/A	Ramp inside XWalk1?	N/A	N/A	Ramp inside XWalk2?	N/A
	Road Slope (%)	N/A	N/A	Clear Space?	Yes
	Road X Slope (%)	N/A	N/A	Clear Space to XWalk (in)	N/A
Yes	Any Obstructions?	No	Yes	Storm Grate/Utility Hazard?	No
	Obstruction Type			Storm Grate/Utility Type	
		N/A			N/A
			Yes	Surface Condition? (G/P)	Good

Possible Solutions:

Remove & Replace Landing.

R304.2.1
