Access Compliance Report Public Rights-of-Way (Curb Ramps)

Intersection ID: 12548 Main Street: W_MARTIN_LUTHER_KING_JRCEO/ss Street: S_TRYON_ST Location: W

ADA ID: 3CFA6189B3D0 Ramp Type: PerpDiag Initial Pass/Fail: Fail Overall Compliance: No Severity Score: 13.75

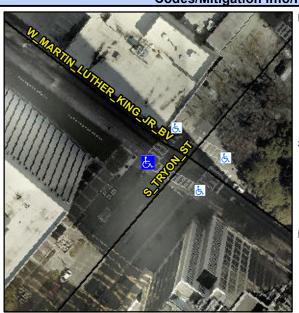
Field Measurements/Component Compliance					
Compliance Description		Data	Compliance Description		Data
N/A	Ramp Length (in)	74.0	No	Ramp Slope (%)	8.4
Yes	Ramp Width (in)	65.0	No	Ramp XSlope (%)	4.3
N/A	Flare Type LT	N/A	N/A	Flare Type RT	N/A
N/A	Flare Slope LT (%)	N/A	N/A	Flare Slope RT (%)	N/A
N/A	Flare Traversable LT?	N/A	N/A	Flare Traversable RT?	N/A
N/A	Landing Length (in)	N/A	N/A	DWS Provided?	N/A
N/A	Landing Width (in)	N/A	N/A	DWS Contrast?	N/A
N/A	Landing Slope (%)	N/A	N/A	DWS Length (in)	N/A
N/A	Landing X Slope (%)	N/A	N/A	DWS Full Width?	N/A
N/A	Landing Curb? (Y/N)	N/A	N/A	DWS Offset (in)	N/A
N/A	Shared Landing?	N/A			
N/A	Gutter Ponding?	N/A	N/A	Gutter Slope (%)	N/A
N/A	Gutter Lip Ht (in)	N/A	N/A	Gutter X Slope (%)	N/A
N/A	Painted X Walk1?	Yes	N/A	Painted X Walk2?	Yes
	X Walk 1 Direction	To SE		X Walk 2 Direction	To NE
N/A	X Walk 1 Width (in)	108.0	N/A	X Walk 2 Width (in)	108.0
	X Walk 1 Slope (%)	1.6		X Walk 2 Slope (%)	N/A

X Walk 1 X Slope (%)	0.8		X Walk 2 X Slope (%)	N/A
N/A	Ramp inside XWalk1?	Yes	N/A	Ramp inside XWalk2?	Yes
	Road Slope (%)	3.0	N/A	Clear Space?	N/A
	Road X Slope (%)	1.9	N/A	Clear Space to XWalk (in)	N/A
N/A	Any Obstructions?	N/A	N/A	Storm Grate/Utility Hazard?	N/A
	Obstruction Type		l	Storm Grate/Utility Type	
		N/A			N/A
			Yes	Surface Condition? (G/P)	Good
	S Lore	· ·	-

Possible Solutions:

Remove & Replace Curb Ramp With Two New Directional Ramps or Equivalent.

R304.2.2, R304.5.3
