# Access Compliance Report

## Public Rights-of-Way

### (Curb Ramps)

| Intersection ID: 16483 | Main Street: QUEENS_RD | Cross Street: RADCLIFFE_AV | Location: W |

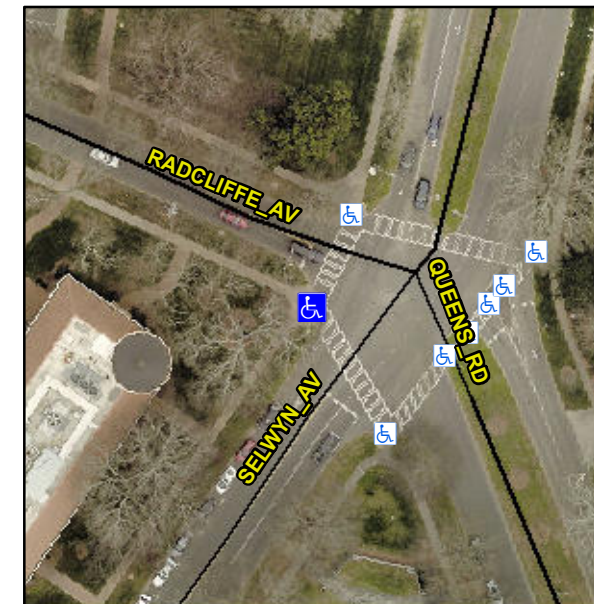
| ADA ID: 3D09B6104ADE | Ramp Type: PerpDiag | Initial Pass/Fail: Fail | Overall Compliance: No |

**Not Found, R304.2.2**

| Compliance | Description | Data | Compliance | Description | Data |
|---|---|---|---|---|---|
| N/A | Ramp Length (in) | 84.0 | No | Ramp Slope (%) | 9.3 |

**Remove & Replace Curb Ramp With Two New Directional Ramps or Equivalent.**

Total Cost: \$ 3200.00
