Access Compliance Report

Public Rights-of-Way

(Curb Ramps)

Intersection ID: 21102	Main Street: S_TRYON_ST	Cross Street: WHITEHALL_PARK_DR	Location: S
ADA ID: 3D0AEBA12AA4	Ramp Type: Perp	Initial Pass/Fail: Fail	Overall Compliance: No
Severity Score: 12.5			
Codes/Mitigation Info/Possible Solution		Field Measurements/Component Compliance

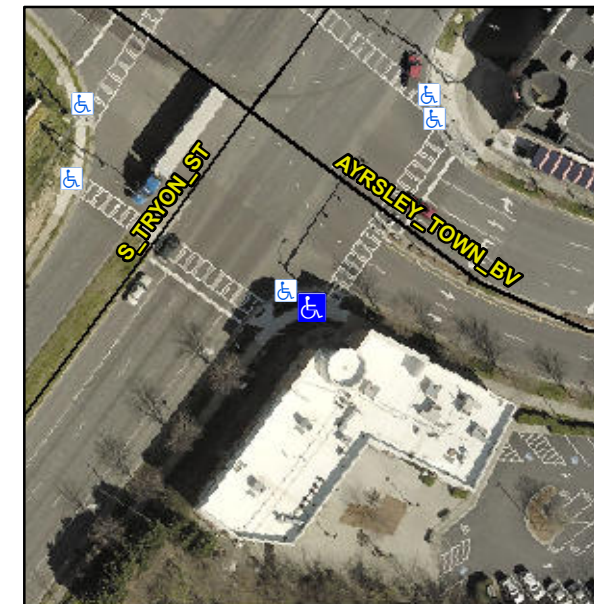
Not Found, R304.2.2

Compliance	Description	Data	Compliance	Description	Data
N/A	Ramp Length (in)	89.0	No	Ramp Slope (%)	8.8
Yes	Ramp Width (in)	70.5	Yes	Ramp XSlope (%)	1.2
N/A	Flare Type LT	N/A	N/A	Flare Type RT	N/A
N/A	Flare Slope LT (%)	N/A	N/A	Flare Slope RT (%)	N/A
N/A	Flare Traversable LT?	N/A	N/A	Flare Traversable RT?	N/A
N/A	Landing Length (in)	N/A	N/A	DWS Provided?	N/A
N/A	Landing Width (in)	N/A	N/A	DWS Contrast?	N/A
N/A	Landing Slope (%)	N/A	N/A	DWS Length (in)	N/A
N/A	Landing X Slope (%)	N/A	N/A	DWS Full Width?	N/A
N/A	Landing Curb? (Y/N)	N/A	N/A	DWS Offset (in)	N/A
N/A	Shared Landing?	N/A			
N/A	Gutter Ponding?	N/A	N/A	Gutter Slope (%)	N/A
N/A	Gutter Lip Ht (in)	N/A	N/A	Gutter X Slope (%)	N/A
N/A	Painted X Walk1?	Yes	N/A	Painted X Walk2?	N/A
	X Walk 1 Direction	To NE		X Walk 2 Direction	N/A
N/A	X Walk 1 Width (in)	111.0	N/A	X Walk 2 Width (in)	N/A
	X Walk 1 Slope (%)	1.6		X Walk 2 Slope (%)	N/A
	X Walk 1 X Slope (%)	1.9		X Walk 2 X Slope (%)	N/A

N/A	Ramp inside XWalk1?	Yes	N/A	Ramp inside XWalk2?	N/A
	Road Slope (%)	N/A	N/A	Clear Space?	N/A
	Road X Slope (%)	N/A	N/A	Clear Space to XWalk (in)	N/A
N/A	Any Obstructions?	N/A	N/A	Storm Grate/Utility Hazard?	N/A
	Obstruction Type			Storm Grate/Utility Type	
		N/A			N/A
			Yes	Surface Condition? (G/P)	Good

Possible Solutions:

Remove & Replace Entire Ramp.

Total Cost: \$ 1850.00
