Access Compliance Report

Public Rights-of-Way

(Curb Ramps)

Intersection ID: 29462	Main Street: E_10TH_ST	Cross Street: GARDEN_DISTRICT_DR	Location: S
ADA ID: 3D107E81063D	Ramp Type: Perp	Initial Pass/Fail: Fail	Overall Compliance: No
		Severity Score: 25

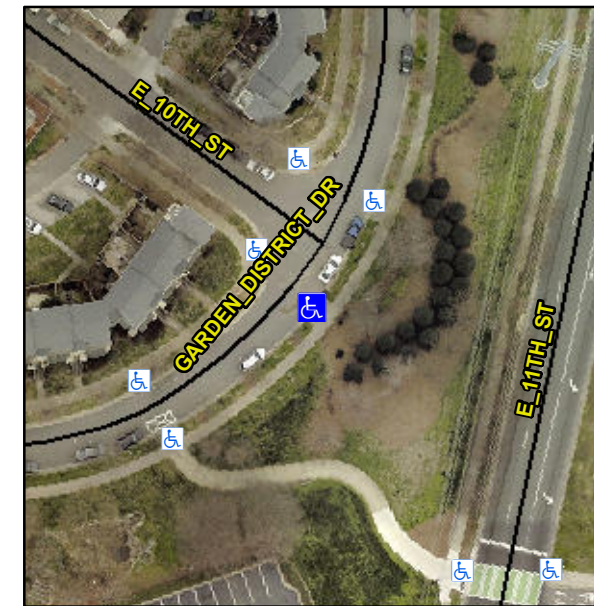
Compliance	Description	Data	Compliance	Description	Data
N/A	Ramp Length (in)	62.0	No	Ramp Slope (%)	14.4
Yes	Ramp Width (in)	120.0	Yes	Ramp XSlope (%)	0.7
N/A	Flare Type LT	N/A	N/A	Flare Type RT	N/A
N/A	Flare Slope LT (%)	N/A	N/A	Flare Slope RT (%)	N/A
N/A	Flare Traversable LT?	N/A	N/A	Flare Traversable RT?	N/A
N/A	Landing Length (in)	N/A	N/A	DWS Provided?	N/A
N/A	Landing Width (in)	N/A	N/A	DWS Contrast?	N/A
N/A	Landing Slope (%)	N/A	N/A	DWS Length (in)	N/A
N/A	Landing X Slope (%)	N/A	N/A	DWS Full Width?	N/A
N/A	Landing Curb? (Y/N)	N/A	N/A	DWS Offset (in)	N/A
N/A	Shared Landing?	N/A			
N/A	Gutter Ponding?	N/A	N/A	Gutter Slope (%)	N/A
N/A	Gutter Lip Ht (in)	N/A	N/A	Gutter X Slope (%)	N/A
N/A	Painted X Walk1?	No	N/A	Painted X Walk2?	N/A
	X Walk 1 Direction	To NW		X Walk 2 Direction	N/A
N/A	X Walk 1 Width (in)	N/A	N/A	X Walk 2 Width (in)	N/A
	X Walk 1 Slope (%)	0.7		X Walk 2 Slope (%)	N/A
	X Walk 1 X Slope (%)	0.8		X Walk 2 X Slope (%)	N/A

Possible Solutions:

Remove & Replace Entire Ramp.

R304.2.2
