Access Compliance Report

Public Rights-of-Way

(Curb Ramps)

Intersection ID: 7759	Main Street: MONTANA_DR	Cross Street: KENDALL_DR	Location: SW
ADA ID: 3D128CB94ABC	Ramp Type: BlendTrans1	Initial Pass/Fail: Fail	Overall Compliance: No
Severity Score: 10			
Codes/Mitigation Info/Possible Solution		Field Measurements/Component Compliance

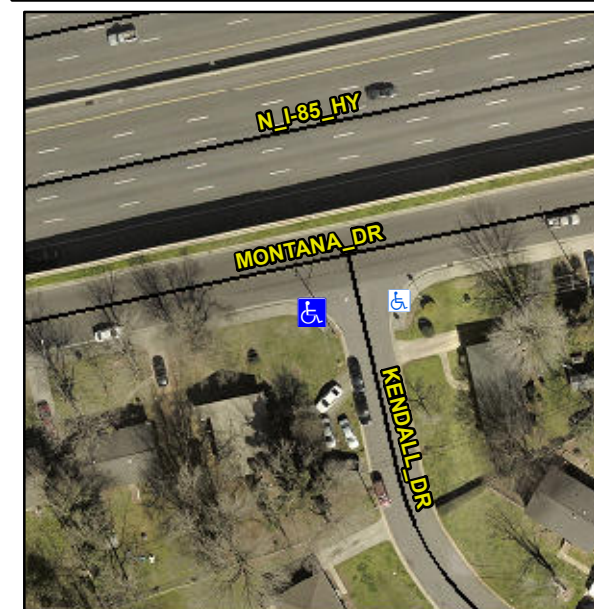
Not Found, R304.5.1, R304.5.3

Compliance	Description	Data	Compliance	Description	Data
N/A	Ramp Length (in)	34.0	Yes	BlendTrans Slope (%)	4.4
No	Ramp Width (in)	36.0	No	BlendTrans XSlope (%)	4.7
N/A	Flare Type LT	N/A	N/A	Flare Type RT	N/A
N/A	Flare Slope LT (%)	N/A	N/A	Flare Slope RT (%)	N/A
N/A	Flare Traversable LT?	N/A	N/A	Flare Traversable RT?	N/A
N/A	Landing Length (in)	N/A	N/A	DWS Provided?	N/A
N/A	Landing Width (in)	N/A	N/A	DWS Contrast?	N/A
N/A	Landing Slope (%)	N/A	N/A	DWS Length (in)	N/A
N/A	Landing X Slope (%)	N/A	N/A	DWS Full Width?	N/A
N/A	Landing Curb? (Y/N)	N/A	N/A	DWS Offset (in)	N/A
N/A	Shared Landing?	N/A			
N/A	Gutter Ponding?	N/A	N/A	Gutter Slope (%)	N/A
N/A	Gutter Lip Ht (in)	N/A	N/A	Gutter X Slope (%)	N/A
N/A	Painted X Walk1?	No	N/A	Painted X Walk2?	N/A
	X Walk 1 Direction	To E		X Walk 2 Direction	N/A
	X Walk 1 Width (in)	N/A		X Walk 2 Width (in)	N/A
	X Walk 1 Slope (%)	3.2		X Walk 2 Slope (%)	N/A
	X Walk 1 X Slope (%)	2.0		X Walk 2 X Slope (%)	N/A

N/A	Ramp inside XWalk1?	N/A	N/A	Ramp inside XWalk2?	N/A
	Road Slope (%)	2.0		Clear Space?	N/A
	Road X Slope (%)	3.2	N/A	Clear Space to XWalk (in)	N/A
N/A	Any Obstructions?	N/A	N/A	Storm Grate/Utility Hazard?	N/A
	Obstruction Type			Storm Grate/Utility Type	
		N/A			N/A
			Yes	Surface Condition? (G/P)	Good
			No	Curb Slope (%)	11.5

Possible Solutions:

Remove & Replace Curb Ramp With Two New Directional Ramps or Equivalent.
