# Access Compliance Report

## Public Rights-of-Way

### (Curb Ramps)

Intersection ID: N/A	Main Street: INDEPENDENCE_RD	Cross Street: N/A	Location: E
ADA ID: 3D152EE856D7	Ramp Type: Directional1	Initial Pass/Fail: Pass	Overall Compliance: No
		Severity Score: 10

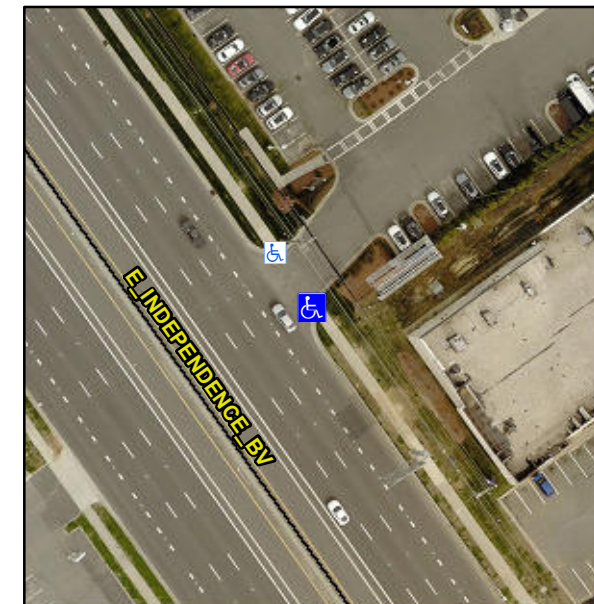
**Not Found, R304.2.2-Perp, R304.3.2-Para, R304.5.2, R305**

Compliance	Description	Data	Compliance	Description	Data
N/A	Ramp Length (in)	62.0	No	Grade Break?	No
Yes	Ramp Width (in)	72.0	N/A	Grade Break Slope (%)	3.5
Yes	Ramp Slope (%)	3.8	N/A	Grade Break XSlope (%)	0.1
Yes	Ramp XSlope (%)	0.7			
N/A	Flare Type LT	N/A	N/A	Flare Type RT	N/A
N/A	Flare Slope LT (%)	N/A	N/A	Flare Slope RT (%)	N/A
N/A	Flare Traversable LT?	N/A	N/A	Flare Traversable RT?	N/A
Yes	Landing Length (in)	64.0	No	DWS Provided?	No
Yes	Landing Width (in)	72.0	N/A	DWS Contrast?	No
No	Landing Slope (%)	3.3	N/A	DWS Length (in)	N/A
Yes	Landing X Slope (%)	0.8	N/A	DWS Full Width?	No
N/A	Landing Curb? (Y/N)	N/A	N/A	DWS Offset LT (in)	N/A
N/A	Shared Landing?	No	N/A	DWS Offset RT (in)	N/A
Yes	Gutter Ponding?	No	Yes	Gutter Slope (%)	1.0
Yes	Gutter Lip Ht (in)	0.0	Yes	Gutter X Slope (%)	0.1
N/A	Painted X Walk1?	No		Road Slope (%)	1.4
	X Walk 1 Direction	To NW		Road X Slope (%)	1.1
	X Walk 1 Width (in)	N/A		Clear Space?	Yes

X Walk 1 Slope (%)	1.4	N/A	Clear Space to XWalk (in)	N/A
	X Walk 1 X Slope (%)	1.1	Yes	Storm Grate/Utility Hazard?	No
N/A	Ramp inside XWalk1?	N/A		Storm Grate/Utility Type	
Yes	Any Obstructions?	No			N/A
	Obstruction Type		Yes	Surface Condition? (G/P)	Good
			N/A	Curb Slope (%)	12.5

**Remove & Replace Entire Ramp.**

Total Cost: \$ 1600.00
