# Access Compliance Report

## Public Rights-of-Way

### (Curb Ramps)

Intersection ID: 3062	Main Street: LOGANVILLE_DR	Cross Street: BENFIELD_RD	Location: W
ADA ID: 3D1D01AFCEC7	Ramp Type: Perp	Initial Pass/Fail: Fail	Overall Compliance: No
		Severity Score: 35

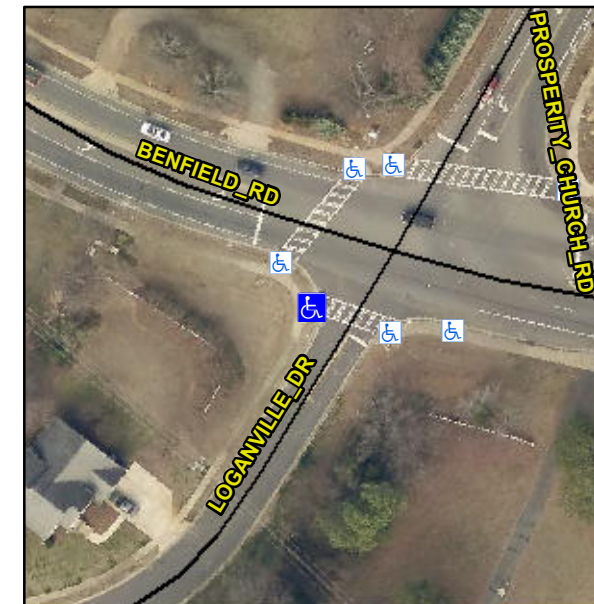
Compliance	Description	Data	Compliance	Description	Data
N/A	Ramp Length (in)	72.0	No	Ramp Slope (%)	20.0
No	Ramp Width (in)	36.5	Yes	Ramp XSlope (%)	3.5
N/A	Flare Type LT	N/A	N/A	Flare Type RT	N/A
N/A	Flare Slope LT (%)	N/A	N/A	Flare Slope RT (%)	N/A
N/A	Flare Traversable LT?	N/A	N/A	Flare Traversable RT?	N/A
N/A	Landing Length (in)	N/A	N/A	DWS Provided?	N/A
N/A	Landing Width (in)	N/A	N/A	DWS Contrast?	N/A
N/A	Landing Slope (%)	N/A	N/A	DWS Length (in)	N/A
N/A	Landing X Slope (%)	N/A	N/A	DWS Full Width?	N/A
N/A	Landing Curb? (Y/N)	N/A	N/A	DWS Offset (in)	N/A
N/A	Shared Landing?	N/A			
N/A	Gutter Ponding?	N/A	N/A	Gutter Slope (%)	N/A
N/A	Gutter Lip Ht (in)	N/A	N/A	Gutter X Slope (%)	N/A
N/A	Painted X Walk1?	Yes	N/A	Painted X Walk2?	N/A
	X Walk 1 Direction	To SE		X Walk 2 Direction	N/A
N/A	X Walk 1 Width (in)	108.0	N/A	X Walk 2 Width (in)	N/A
	X Walk 1 Slope (%)	4.1		X Walk 2 Slope (%)	N/A
	X Walk 1 X Slope (%)	4.7		X Walk 2 X Slope (%)	N/A

N/A	Ramp inside XWalk1?	Yes	N/A	Ramp inside XWalk2?	N/A
	Road Slope (%)	N/A	N/A	Clear Space?	N/A
	Road X Slope (%)	N/A	N/A	Clear Space to XWalk (in)	N/A
N/A	Any Obstructions?	N/A	N/A	Storm Grate/Utility Hazard?	N/A
	Obstruction Type			Storm Grate/Utility Type	
		N/A			N/A
		Yes		Surface Condition? (G/P)	Good

**Remove & Replace Entire Ramp.**

**R304.5.1, R304.2.2**
