# Access Compliance Report

## Public Rights-of-Way

Intersection ID: 8204	Main Street: BEATTIES_FORD_RD	Cross Street: CATHERINE_SIMMONS_AV	Location: SW
ADA ID: 3D1DC136D156	Ramp Type: PerpDiag	Initial Pass/Fail: Fail	Overall Compliance: No
Severity Score: 21.25			
Codes/Mitigation Info/Possible Solution		Field Measurements/Component Compliance

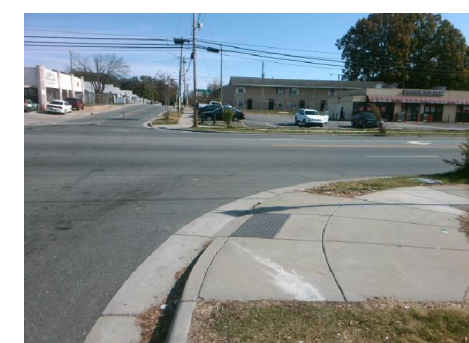
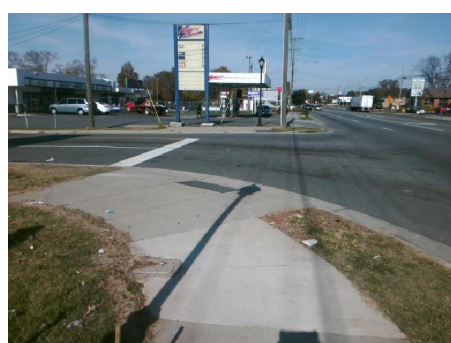
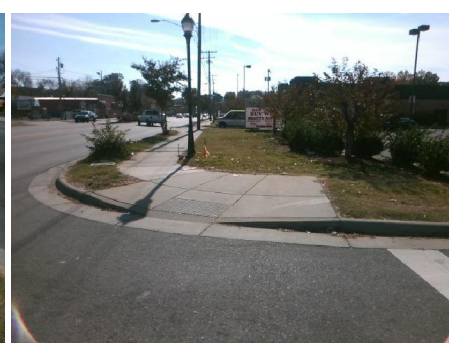
Compliance	Description	Data	Compliance	Description	Data
N/A	Ramp Length (in)	48.0	No	Ramp Slope (%)	8.5
No	Ramp Width (in)	45.5	Yes	Ramp XSlope (%)	0.7
N/A	Flare Type LT	N/A	N/A	Flare Type RT	N/A
N/A	Flare Slope LT (%)	N/A	N/A	Flare Slope RT (%)	N/A
N/A	Flare Traversable LT?	N/A	N/A	Flare Traversable RT?	N/A
N/A	Landing Length (in)	N/A	N/A	DWS Provided?	N/A
N/A	Landing Width (in)	N/A	N/A	DWS Contrast?	N/A
N/A	Landing Slope (%)	N/A	N/A	DWS Length (in)	N/A
N/A	Landing X Slope (%)	N/A	N/A	DWS Full Width?	N/A
N/A	Landing Curb? (Y/N)	N/A	N/A	DWS Offset (in)	N/A
N/A	Shared Landing?	N/A			
N/A	Gutter Ponding?	N/A	N/A	Gutter Slope (%)	N/A
N/A	Gutter Lip Ht (in)	N/A	N/A	Gutter X Slope (%)	N/A
N/A	Painted X Walk1?	No	N/A	Painted X Walk2?	No
	X Walk 1 Direction	To E		X Walk 2 Direction	To N
N/A	X Walk 1 Width (in)	N/A	N/A	X Walk 2 Width (in)	N/A
	X Walk 1 Slope (%)	2.3		X Walk 2 Slope (%)	0.2
	X Walk 1 X Slope (%)	1.8		X Walk 2 X Slope (%)	2.0

N/A	Ramp inside XWalk1?	N/A	N/A	Ramp inside XWalk2?	N/A
	Road Slope (%)	1.4	N/A	Clear Space?	N/A
	Road X Slope (%)	1.0	N/A	Clear Space to XWalk (in)	N/A
N/A	Any Obstructions?	N/A	N/A	Storm Grate/Utility Hazard?	N/A
	Obstruction Type			Storm Grate/Utility Type	
		N/A			N/A
		Yes		Surface Condition? (G/P)	Good

**Remove & Replace Curb Ramp With Two New Directional Ramps or Equivalent.**
