Access Compliance Report

Public Rights-of-Way

(Curb Ramps)

Intersection ID: 30007	Main Street: DUNBERRY_CT	Cross Street: OAKBORO_LN	Location: NE
ADA ID: 3D1EEFEF866F	Ramp Type: PerpDiag	Initial Pass/Fail: Fail	Overall Compliance: No
Codes/Mitigation Info/Possible Solution		Field Measurements/Component Compliance	
Severity Score: 33.75

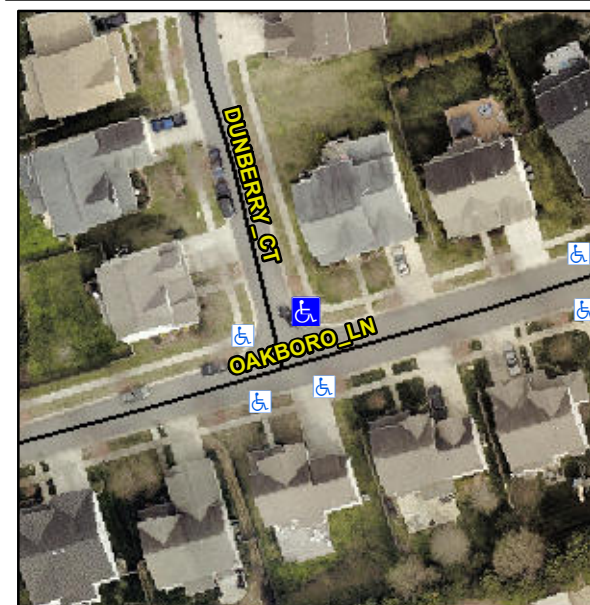
Not Found, R304.5.1, R304.5.3

Compliance	Description	Data	Compliance	Description	Data
N/A	Ramp Length (in)	69.5	Yes	Ramp Slope (%)	6.5
No	Ramp Width (in)	47.0	No	Ramp XSlope (%)	11.8
N/A	Flare Type LT	N/A	N/A	Flare Type RT	N/A
N/A	Flare Slope LT (%)	N/A	N/A	Flare Slope RT (%)	N/A
N/A	Flare Traversable LT?	N/A	N/A	Flare Traversable RT?	N/A
N/A	Landing Length (in)	N/A	N/A	DWS Provided?	N/A
N/A	Landing Width (in)	N/A	N/A	DWS Contrast?	N/A
N/A	Landing Slope (%)	N/A	N/A	DWS Length (in)	N/A
N/A	Landing X Slope (%)	N/A	N/A	DWS Full Width?	N/A
N/A	Landing Curb? (Y/N)	N/A	N/A	DWS Offset (in)	N/A
N/A	Shared Landing?	N/A			
N/A	Gutter Ponding?	N/A	N/A	Gutter Slope (%)	N/A
N/A	Gutter Lip Ht (in)	N/A	N/A	Gutter X Slope (%)	N/A
N/A	Painted X Walk1?	No	N/A	Painted X Walk2?	No
	X Walk 1 Direction	To W		X Walk 2 Direction	To S
N/A	X Walk 1 Width (in)	N/A	N/A	X Walk 2 Width (in)	N/A
	X Walk 1 Slope (%)	3.9		X Walk 2 Slope (%)	5.2
	X Walk 1 X Slope (%)	1.7		X Walk 2 X Slope (%)	8.9

N/A	Ramp inside XWalk1?	N/A	N/A	Ramp inside XWalk2?	N/A
	Road Slope (%)	7.2	N/A	Clear Space?	N/A
	Road X Slope (%)	2.0	N/A	Clear Space to XWalk (in)	N/A
N/A	Any Obstructions?	N/A	N/A	Storm Grate/Utility Hazard?	N/A
	Obstruction Type			Storm Grate/Utility Type	
		N/A			N/A
		Yes		Surface Condition? (G/P)	Good

Remove & Replace Curb Ramp With Two New Directional Ramps or Equivalent.
