Access Compliance Report

Public Rights-of-Way

(Curb Ramps)

Intersection ID: 19457	Main Street: S_TRYON_ST	Cross Street: YORKDALE_DR	Location: NW
ADA ID: 3D205B7AE61E	Ramp Type: PerpDiag	Initial Pass/Fail: Pass	Overall Compliance: No
Severity Score: 22.5			
Codes/Mitigation Info/Possible Solution		Field Measurements/Component Compliance

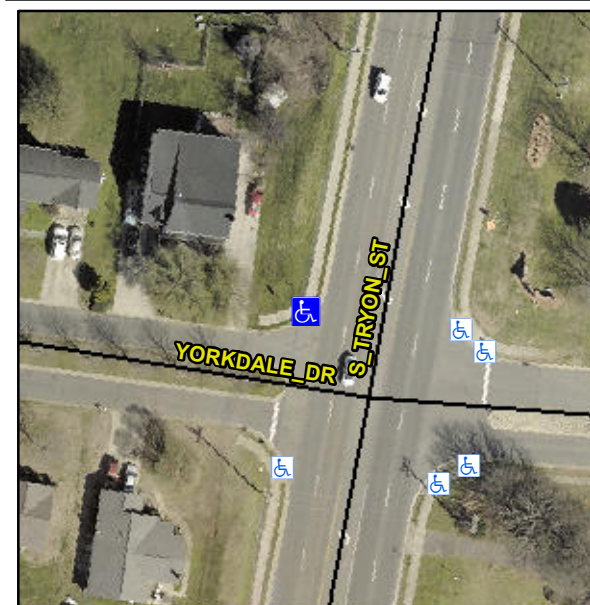
Compliance	Description	Data	Compliance	Description	Data
N/A	Ramp Length (in)	91.0	Yes	Ramp Slope (%)	7.7
Yes	Ramp Width (in)	48.0	Yes	Ramp XSlope (%)	0.6
N/A	Flare Type LT	Sloped	N/A	Flare Type RT	N/A
N/A	Flare Slope LT (%)	6.6	No	Flare Slope RT (%)	11.2
N/A	Flare Traversable LT?	Yes	N/A	Flare Traversable RT?	Yes
No	Landing Length (in)	N/A	No	DWS Provided?	No
No	Landing Width (in)	N/A	N/A	DWS Contrast?	No
No	Landing Slope (%)	N/A	N/A	DWS Length (in)	N/A
No	Landing X Slope (%)	N/A	N/A	DWS Full Width?	No
N/A	Landing Curb? (Y/N)	No	N/A	DWS Offset (in)	N/A
N/A	Shared Landing?	No			
Yes	Gutter Ponding?	No	Yes	Gutter Slope (%)	4.4
Yes	Gutter Lip Ht (in)	0.0	Yes	Gutter X Slope (%)	1.4
N/A	Painted X Walk1?	No	N/A	Painted X Walk2?	No
	X Walk 1 Direction	To S		X Walk 2 Direction	To E
N/A	X Walk 1 Width (in)	N/A	N/A	X Walk 2 Width (in)	N/A
	X Walk 1 Slope (%)	1.1		X Walk 2 Slope (%)	0.6
	X Walk 1 X Slope (%)	2.2		X Walk 2 X Slope (%)	0.0

N/A	Ramp inside XWalk1?	N/A	N/A	Ramp inside XWalk2?	N/A
	Road Slope (%)	1.6	N/A	Clear Space?	Yes
	Road X Slope (%)	3.8	N/A	Clear Space to XWalk (in)	N/A
Yes	Any Obstructions?	No	Yes	Storm Grate/Utility Hazard?	No
	Obstruction Type			Storm Grate/Utility Type	
		N/A			N/A
			Yes	Surface Condition? (G/P)	Good

Possible Solutions:

Remove & Replace Curb Ramp With Two New Directional Ramps or Equivalent.
