Access Compliance Report

Public Rights-of-Way

(Curb Ramps)

Intersection ID: 10315	Main Street: E_34TH_ST	Cross Street: N_ALEXANDER_ST	Location: N
ADA ID: 3D274951C48F	Ramp Type: Directional1	Initial Pass/Fail: Fail	Overall Compliance: No
		Severity Score: 8.75	
Codes/Mitigation Info/Possible Solution		Field Measurements/Component Compliance

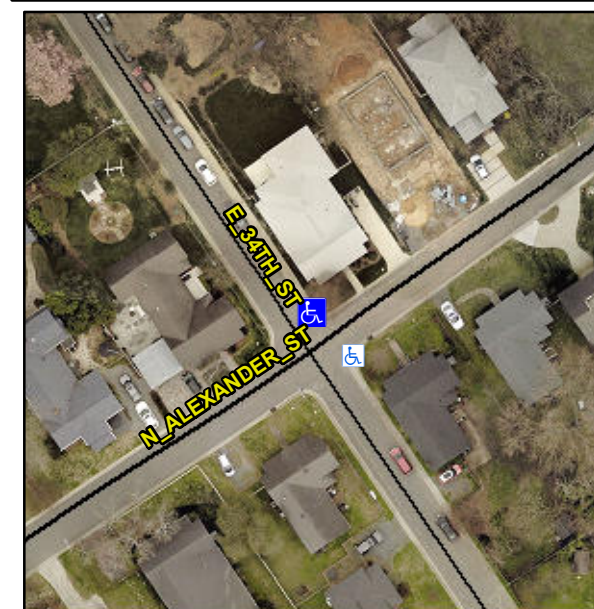
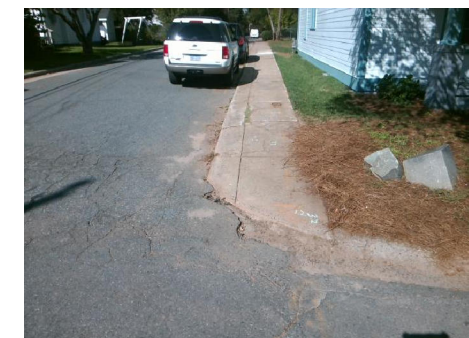
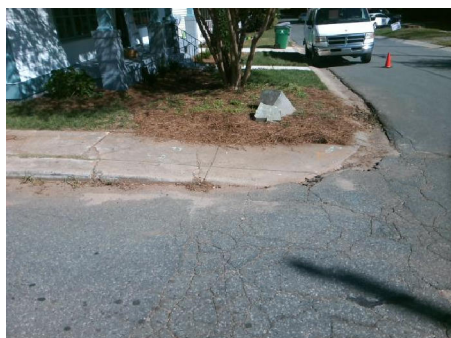
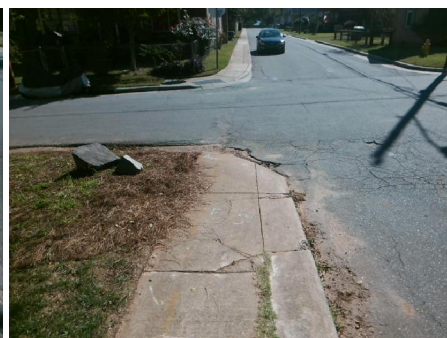
NO CURB

Compliance	Description	Data	Compliance	Description	Data
N/A	Ramp Length (in)	116.0	N/A	Grade Break?	N/A
No	Ramp Width (in)	37.0	N/A	Grade Break Slope (%)	0.0
Yes	Ramp Slope (%)	7.7	N/A	Grade Break XSlope (%)	0.0
Yes	Ramp XSlope (%)	1.7			
N/A	Flare Type LT	N/A	N/A	Flare Type RT	N/A
N/A	Flare Slope LT (%)	N/A	N/A	Flare Slope RT (%)	0.0
N/A	Flare Traversable LT?	N/A	N/A	Flare Traversable RT?	N/A
N/A	Landing Length (in)	0.0	N/A	DWS Provided?	N/A
N/A	Landing Width (in)	0.0	N/A	DWS Contrast?	N/A
N/A	Landing Slope (%)	0.0	N/A	DWS Length (in)	N/A
N/A	Landing X Slope (%)	0.0	N/A	DWS Full Width?	N/A
N/A	Landing Curb? (Y/N)	N/A	N/A	DWS Offset LT (in)	N/A
N/A	Shared Landing?	N/A	N/A	DWS Offset RT (in)	N/A
N/A	Gutter Ponding?	0.0	N/A	Gutter Slope (%)	N/A
N/A	Gutter Lip Ht (in)	0.0	N/A	Gutter X Slope (%)	N/A
N/A	Painted X Walk1?	No		Road Slope (%)	0.0
	X Walk 1 Direction	To SE		Road X Slope (%)	3.7
	X Walk 1 Width (in)	N/A		Clear Space?	N/A

X Walk 1 Slope (%)	0.0	N/A	Clear Space to XWalk (in)	N/A
	X Walk 1 X Slope (%)	3.7	N/A	Storm Grate/Utility Hazard?	N/A
N/A	Ramp inside XWalk1?	N/A		Storm Grate/Utility Type	
N/A	Any Obstructions?	N/A			N/A
	Obstruction Type		Yes	Surface Condition? (G/P)	Good
			N/A	Curb Slope (%)	5.4

Possible Solutions:

Remove & Replace Entire Ramp.

PROW/ADA:

R304.5.1
