# Access Compliance Report

## Public Rights-of-Way

### (Curb Ramps)

Intersection ID: 17898	Main Street: KINGMAN_DR	Cross Street: S_TRYON_ST	Location: NE
ADA ID: 3D2A0747D6F8	Ramp Type: Perp	Initial Pass/Fail: Pass	Overall Compliance: No
Severity Score: 20			
Codes/Mitigation Info/Possible Solution		Field Measurements/Component Compliance

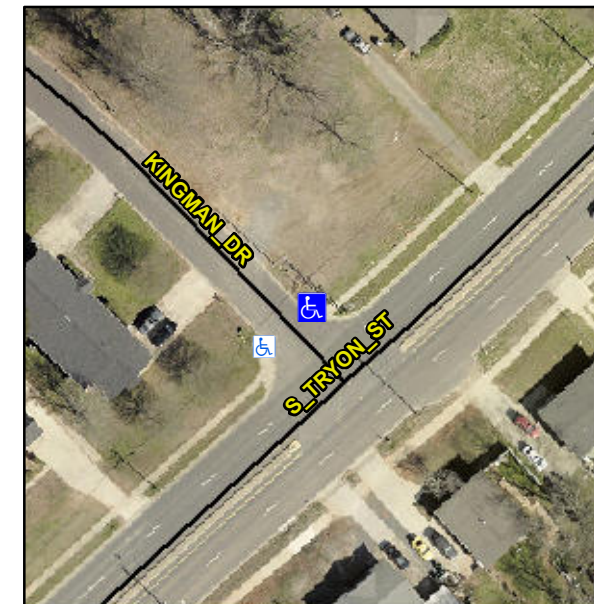
**Not Found, R304.2.1, R304.2.2-Perp,  
R304.3.2-Para, R304.5.3, R305**

Compliance	Description	Data	Compliance	Description	Data
N/A	Ramp Length (in)	56.0	Yes	Ramp Slope (%)	6.6
Yes	Ramp Width (in)	48.0	Yes	Ramp XSlope (%)	0.9
N/A	Flare Type LT	None	N/A	Flare Type RT	N/A
N/A	Flare Slope LT (%)	N/A	Yes	Flare Slope RT (%)	2.4
N/A	Flare Traversable LT?	N/A	N/A	Flare Traversable RT?	Yes
No	Landing Length (in)	N/A	No	DWS Provided?	No
No	Landing Width (in)	N/A	N/A	DWS Contrast?	No
No	Landing Slope (%)	N/A	N/A	DWS Length (in)	N/A
No	Landing X Slope (%)	N/A	N/A	DWS Full Width?	No
N/A	Landing Curb? (Y/N)	No	N/A	DWS Offset (in)	N/A
N/A	Shared Landing?	No			
Yes	Gutter Ponding?	No	Yes	Gutter Slope (%)	0.6
Yes	Gutter Lip Ht (in)	0.0	No	Gutter X Slope (%)	2.4
N/A	Painted X Walk1?	No	N/A	Painted X Walk2?	N/A
	X Walk 1 Direction	To SW		X Walk 2 Direction	N/A
N/A	X Walk 1 Width (in)	N/A	N/A	X Walk 2 Width (in)	N/A
	X Walk 1 Slope (%)	3.2		X Walk 2 Slope (%)	N/A
	X Walk 1 X Slope (%)	1.4		X Walk 2 X Slope (%)	N/A

N/A	Ramp inside XWalk1?	N/A	N/A	Ramp inside XWalk2?	N/A
	Road Slope (%)	N/A	N/A	Clear Space?	Yes
	Road X Slope (%)	N/A	N/A	Clear Space to XWalk (in)	N/A
Yes	Any Obstructions?	No	Yes	Storm Grate/Utility Hazard?	No
	Obstruction Type			Storm Grate/Utility Type	
		N/A			N/A
			Yes	Surface Condition? (G/P)	Good

**Remove & Replace Entire Ramp.  
Remove & Replace Gutter.**
