# Access Compliance Report

## Public Rights-of-Way

### (Curb Ramps)

Intersection ID: 15398	Main Street: COLVILLE_RD	Cross Street: HEMPSTEAD_PL	Location: SW
ADA ID: 3D2D68B02B87	Ramp Type: PerpDiag	Initial Pass/Fail: Fail	Overall Compliance: No
		Severity Score: 12.5

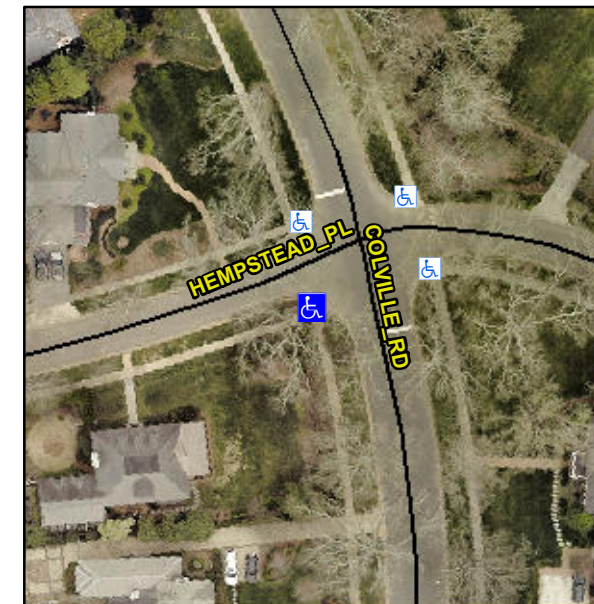
**Not Found, R304.2.2**

Compliance	Description	Data	Compliance	Description	Data
N/A	Ramp Length (in)	63.0	No	Ramp Slope (%)	10.2
Yes	Ramp Width (in)	48.0	Yes	Ramp XSlope (%)	0.2
N/A	Flare Type LT	N/A	N/A	Flare Type RT	N/A
N/A	Flare Slope LT (%)	N/A	N/A	Flare Slope RT (%)	N/A
N/A	Flare Traversable LT?	N/A	N/A	Flare Traversable RT?	N/A
N/A	Landing Length (in)	N/A	N/A	DWS Provided?	N/A
N/A	Landing Width (in)	N/A	N/A	DWS Contrast?	N/A
N/A	Landing Slope (%)	N/A	N/A	DWS Length (in)	N/A
N/A	Landing X Slope (%)	N/A	N/A	DWS Full Width?	N/A
N/A	Landing Curb? (Y/N)	N/A	N/A	DWS Offset (in)	N/A
N/A	Shared Landing?	N/A			
N/A	Gutter Ponding?	Yes	N/A	Gutter Slope (%)	N/A
N/A	Gutter Lip Ht (in)	N/A	N/A	Gutter X Slope (%)	N/A
N/A	Painted X Walk1?	No	N/A	Painted X Walk2?	No
	X Walk 1 Direction	To E		X Walk 2 Direction	To N
N/A	X Walk 1 Width (in)	N/A	N/A	X Walk 2 Width (in)	N/A
	X Walk 1 Slope (%)	1.9		X Walk 2 Slope (%)	3.8
	X Walk 1 X Slope (%)	2.9		X Walk 2 X Slope (%)	0.5

N/A	Ramp inside XWalk1?	N/A	N/A	Ramp inside XWalk2?	N/A
	Road Slope (%)	1.6	N/A	Clear Space?	N/A
	Road X Slope (%)	4.4	N/A	Clear Space to XWalk (in)	N/A
N/A	Any Obstructions?	N/A	N/A	Storm Grate/Utility Hazard?	N/A
	Obstruction Type			Storm Grate/Utility Type	
		N/A			N/A
		Yes		Surface Condition? (G/P)	Good

**Remove & Replace Curb Ramp With Two New Directional Ramps or Equivalent.**

Total Cost: \$ 3200.00
