# Access Compliance Report

## Public Rights-of-Way

### (Curb Ramps)

Intersection ID: 51704	Main Street: IKEA_BV	Cross Street: BROOKSIDE_LN	Location: W
ADA ID: 3D336406F8B6	Ramp Type: Perp	Initial Pass/Fail: Fail	Overall Compliance: No
Severity Score: 10			
Codes/Mitigation Info/Possible Solution		Field Measurements/Component Compliance

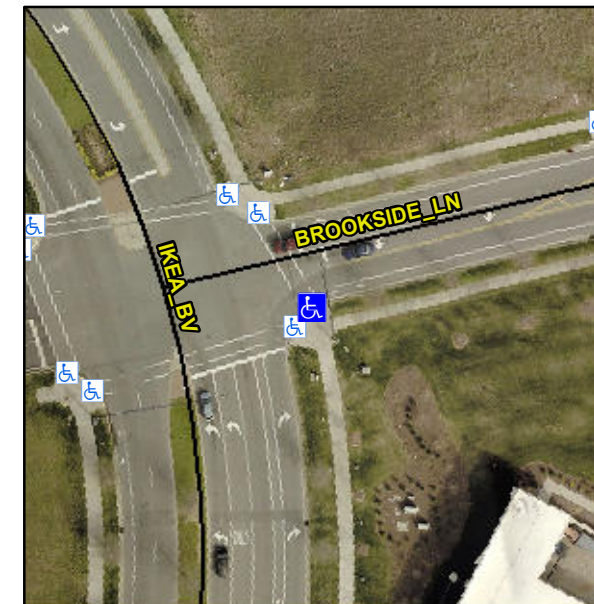
**Not Found, R304.5.1, R304.5.3**

Compliance	Description	Data	Compliance	Description	Data
N/A	Ramp Length (in)	107.0	Yes	Ramp Slope (%)	7.2
No	Ramp Width (in)	47.0	No	Ramp XSlope (%)	4.1
N/A	Flare Type LT	N/A	N/A	Flare Type RT	N/A
N/A	Flare Slope LT (%)	N/A	N/A	Flare Slope RT (%)	N/A
N/A	Flare Traversable LT?	N/A	N/A	Flare Traversable RT?	N/A
N/A	Landing Length (in)	N/A	N/A	DWS Provided?	N/A
N/A	Landing Width (in)	N/A	N/A	DWS Contrast?	N/A
N/A	Landing Slope (%)	N/A	N/A	DWS Length (in)	N/A
N/A	Landing X Slope (%)	N/A	N/A	DWS Full Width?	N/A
N/A	Landing Curb? (Y/N)	N/A	N/A	DWS Offset (in)	N/A
N/A	Shared Landing?	N/A			
N/A	Gutter Ponding?	N/A	N/A	Gutter Slope (%)	N/A
N/A	Gutter Lip Ht (in)	0.5	N/A	Gutter X Slope (%)	N/A
N/A	Painted X Walk1?	Yes	N/A	Painted X Walk2?	N/A
	X Walk 1 Direction	To NW		X Walk 2 Direction	N/A
N/A	X Walk 1 Width (in)	95.0	N/A	X Walk 2 Width (in)	N/A
	X Walk 1 Slope (%)	0.6		X Walk 2 Slope (%)	N/A
	X Walk 1 X Slope (%)	3.3		X Walk 2 X Slope (%)	N/A

N/A	Ramp inside XWalk1?	Yes	N/A	Ramp inside XWalk2?	N/A
	Road Slope (%)	N/A	N/A	Clear Space?	N/A
	Road X Slope (%)	N/A	N/A	Clear Space to XWalk (in)	N/A
N/A	Any Obstructions?	N/A	N/A	Storm Grate/Utility Hazard?	N/A
	Obstruction Type			Storm Grate/Utility Type	
		N/A			N/A
		Yes		Surface Condition? (G/P)	Good

**Remove & Replace Entire Ramp.**
