# Access Compliance Report

## Public Rights-of-Way

| Intersection ID: 19052 | Main Street: COOPER_DR | Cross Street: TYVOLA_RD | Location: NE |
| ADA ID: 3D3DC5E7AAA6 | Ramp Type: BlendTrans1 | Initial Pass/Fail: Pass | Overall Compliance: No |

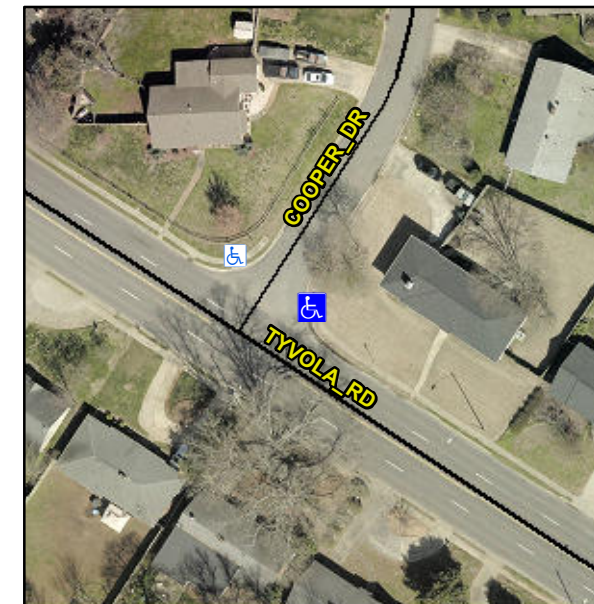
| Severity Score: 6.5 | | | |

**Not Found, R304.2.1, R305.1.4, R305.2**

| Compliance | Description | Data | Compliance | Description | Data |
|---|---|---|---|---|---|
| No | Landing Length (in) | 28.0 | Yes | DWS Provided? | Yes |
| No | Landing Width (in) | 45.0 | Yes | DWS Contrast? | Yes |
| Yes | Landing Slope (%) | 2.0 | No | DWS Length (in) | 23.0 |
| Yes | Landing X Slope (%) | 0.5 | No | DWS Full Width? | No |
| N/A | Landing Curb? (Y/N) | No | No | DWS Offset (in) | 7.0 |
| | | | No | Curb Slope (%) | 14.1 |

**Remove & Replace Curb Ramp With Two New Directional Ramps or Equivalent.**

Total Cost: \$ 3200.00
