# Access Compliance Report

## Public Rights-of-Way

### (Curb Ramps)

Intersection ID: 49925	Main Street: PAXTON_RUN_RD	Cross Street: CAMPBELL_HALL_CT	Location: NE
ADA ID: 3D4554D835FE	Ramp Type: Perp	Initial Pass/Fail: Fail	Overall Compliance: No
Severity Score: 8.75			
Codes/Mitigation Info/Possible Solution		Field Measurements/Component Compliance

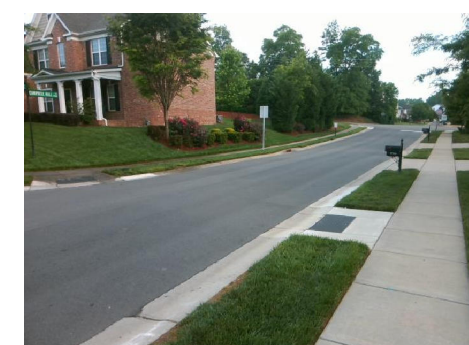
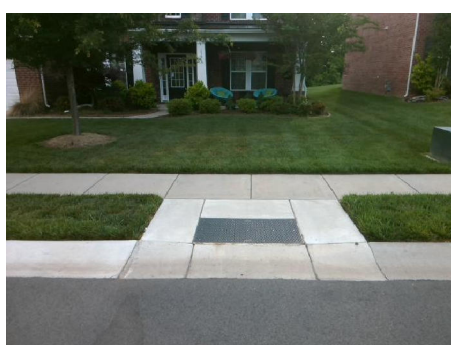
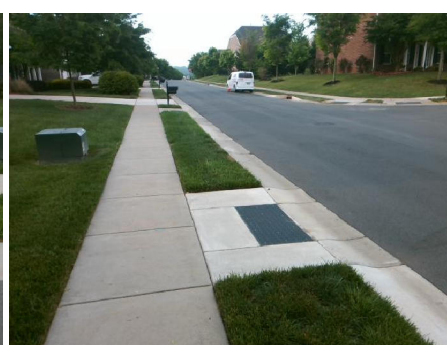
Compliance	Description	Data	Compliance	Description	Data
N/A	Ramp Length (in)	49.0	Yes	Ramp Slope (%)	5.0
No	Ramp Width (in)	47.0	Yes	Ramp XSlope (%)	0.7
N/A	Flare Type LT	N/A	N/A	Flare Type RT	N/A
N/A	Flare Slope LT (%)	N/A	N/A	Flare Slope RT (%)	N/A
N/A	Flare Traversable LT?	N/A	N/A	Flare Traversable RT?	N/A
N/A	Landing Length (in)	N/A	N/A	DWS Provided?	N/A
N/A	Landing Width (in)	N/A	N/A	DWS Contrast?	N/A
N/A	Landing Slope (%)	N/A	N/A	DWS Length (in)	N/A
N/A	Landing X Slope (%)	N/A	N/A	DWS Full Width?	N/A
N/A	Landing Curb? (Y/N)	N/A	N/A	DWS Offset (in)	N/A
N/A	Shared Landing?	N/A			
N/A	Gutter Ponding?	N/A	N/A	Gutter Slope (%)	N/A
N/A	Gutter Lip Ht (in)	N/A	N/A	Gutter X Slope (%)	N/A
N/A	Painted X Walk1?	No	N/A	Painted X Walk2?	N/A
	X Walk 1 Direction	To SW		X Walk 2 Direction	N/A
N/A	X Walk 1 Width (in)	N/A	N/A	X Walk 2 Width (in)	N/A
	X Walk 1 Slope (%)	3.3		X Walk 2 Slope (%)	N/A
	X Walk 1 X Slope (%)	0.7		X Walk 2 X Slope (%)	N/A

N/A	Ramp inside XWalk1?	N/A	N/A	Ramp inside XWalk2?	N/A
	Road Slope (%)	N/A	N/A	Clear Space?	N/A
	Road X Slope (%)	N/A	N/A	Clear Space to XWalk (in)	N/A
N/A	Any Obstructions?	N/A	N/A	Storm Grate/Utility Hazard?	N/A
	Obstruction Type			Storm Grate/Utility Type	
		N/A			N/A
			Yes	Surface Condition? (G/P)	Good

Possible Solutions:

**Remove & Replace Entire Ramp.**

**Not Found, R304.5.1**
