Access Compliance Report Public Rights-of-Way (Curb Ramps)

Intersection ID: 12721 Main Street: S_CHURCH_ST Cross Street: W_HILL_ST Location: S

ADA ID: 3D4A80B76B50 Ramp Type: Perp Initial Pass/Fail: Pass Overall Compliance: No Severity Score: 12.5

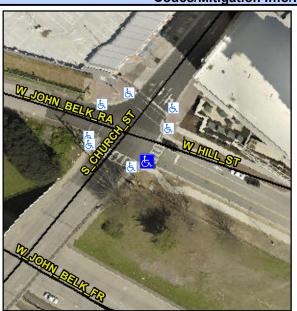
Field Measurements/Component Compliance					
Compliance Description		Data	Compliance Description		Data
N/A	Ramp Length (in)	72.0	Yes	Ramp Slope (%)	6.7
Yes	Ramp Width (in)	60.0	Yes	Ramp XSlope (%)	2.0
N/A	Flare Type LT	Sloped	N/A	Flare Type RT	N/A
N/A	Flare Slope LT (%)	3.2	No	Flare Slope RT (%)	10.2
N/A	Flare Traversable LT?	Yes	N/A	Flare Traversable RT?	Yes
No	Landing Length (in)	N/A	Yes	DWS Provided?	Yes
No	Landing Width (in)	N/A	Yes	DWS Contrast?	Yes
No	Landing Slope (%)	N/A	Yes	DWS Length (in)	24.0
No	Landing X Slope (%)	N/A	Yes	DWS Full Width?	Yes
N/A	Landing Curb? (Y/N)	No	No	DWS Offset (in)	3.0
N/A	Shared Landing?	No			
Yes	Gutter Ponding?	No	Yes	Gutter Slope (%)	2.3
Yes	Gutter Lip Ht (in)	0.0	No	Gutter X Slope (%)	2.7
N/A	Painted X Walk1?	Yes	N/A	Painted X Walk2?	N/A
	X Walk 1 Direction	To NE		X Walk 2 Direction	N/A
N/A	X Walk 1 Width (in)	109.0	N/A	X Walk 2 Width (in)	N/A
	X Walk 1 Slope (%)	0.9		X Walk 2 Slope (%)	N/A

X Walk 1 X Slope (%)	2.5		X Walk 2 X Slope (%)	N/A
Yes	Ramp inside XWalk1?	Yes	N/A	Ramp inside XWalk2?	N/A
	Road Slope (%)	N/A	N/A	Clear Space?	Yes
	Road X Slope (%)	N/A	N/A	Clear Space to XWalk (in)	N/A
Yes	Any Obstructions?	No	Yes	Storm Grate/Utility Hazard?	No
	Obstruction Type			Storm Grate/Utility Type	
		N/A			N/A
			Yes	Surface Condition? (G/P)	Good

Remove & Replace Entire Ramp.
Remove & Replace Gutter.
