# Access Compliance Report

## Public Rights-of-Way

### (Curb Ramps)

| Intersection ID: 53016 | Main Street: STEEL_HOUSE_BV | Cross Street: BESSEMER_ST | Location: SW |

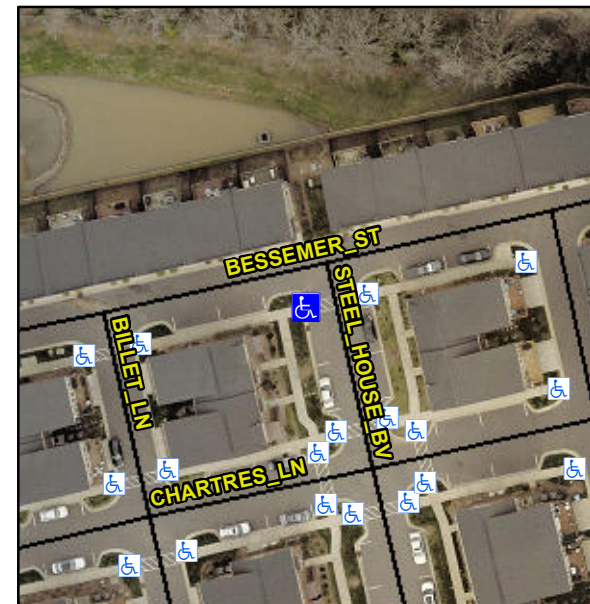
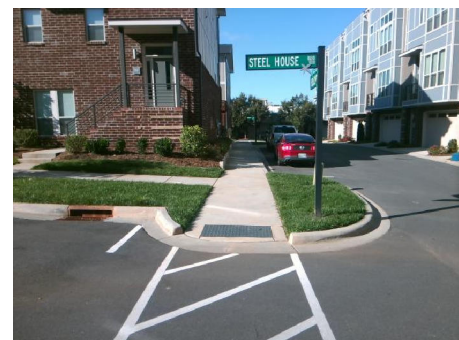
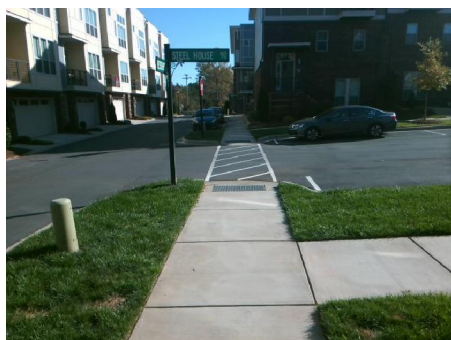
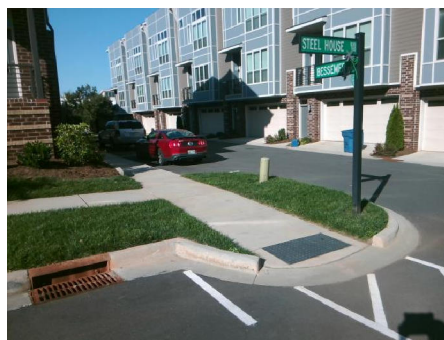
| ADA ID: 3D52780A7DCD | Ramp Type: BlendTrans1 | Initial Pass/Fail: Pass | Overall Compliance: No |

**R304.5.3, R305.1.4, R305.2, R302.7.2**

| Compliance | Description | Data | Compliance | Description | Data |
|---|---|---|---|---|---|
| No | Landing X Slope (%) | 2.6 | No | DWS Full Width? | No |
| N/A | Landing Curb? (Y/N) | No | No | DWS Offset (in) | 9.0 |
| No | Gutter Lip Ht (in) | 0.3 | Yes | Gutter X Slope (%) | 0.9 |

**Remove & Replace Curb Ramp With Two New Directional Ramps or Equivalent. Grind Gutter Lip.**
