Access Compliance Report

Public Rights-of-Way

(Curb Ramps)

Intersection ID: 11497	Main Street: MARGARET_BROWN_ST	Cross Street: S_IRWIN_AV	Location: NW
ADA ID: 3D52E91BC8F3	Ramp Type: Para	Initial Pass/Fail: Fail	Overall Compliance: No
Severity Score: 13.75			
Codes/Mitigation Info/Possible Solution		Field Measurements/Component Compliance

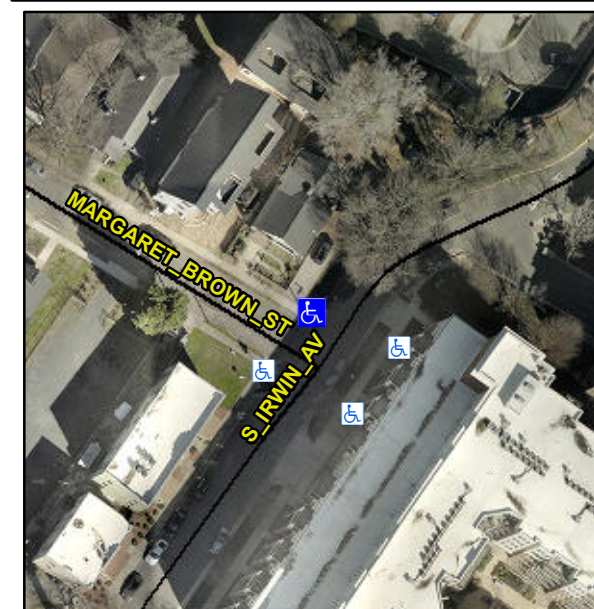
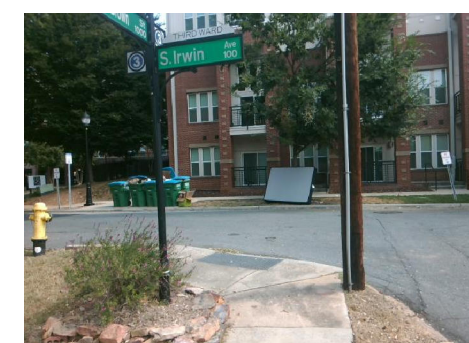
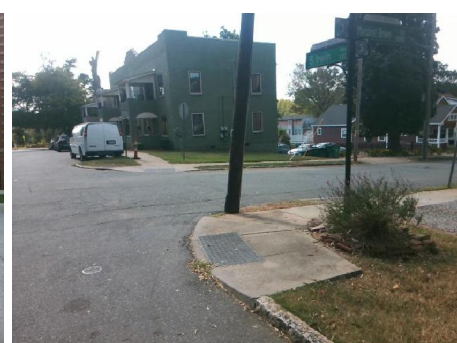
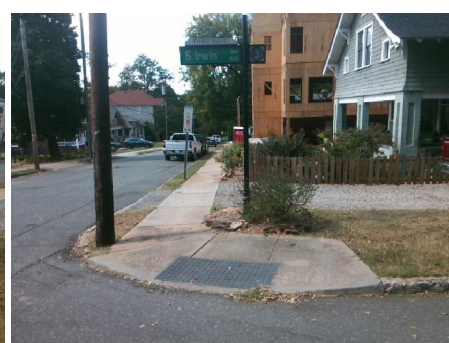
NO CURB LINE

R304.3.2, R304.5.3

Compliance	Description	Data	Compliance	Description	Data
N/A	Ramp Length LT (in)	32.0	N/A	Ramp Length RT (in)	44.0
Yes	Ramp Width LT (in)	48.0	Yes	Ramp Width RT (in)	48.0
Yes	Ramp Slope LT (%)	0.3	No	Ramp Slope RT (%)	10.3
Yes	Ramp XSlope LT (%)	2.0	No	Ramp XSlope RT (%)	3.3
N/A	Landing Length (in)	N/A	N/A	DWS Provided?	N/A
N/A	Landing Width (in)	N/A	N/A	DWS Contrast?	N/A
N/A	Landing Slope (%)	N/A	N/A	DWS Length (in)	N/A
N/A	Landing X Slope (%)	N/A	N/A	DWS Full Width?	N/A
N/A	Landing Curb? (Y/N)	N/A	N/A	DWS Offset (in)	N/A
N/A	Shared Landing?	N/A			
N/A	Gutter Ponding?	N/A	N/A	Gutter Slope (%)	N/A
N/A	Gutter Lip Ht (in)	N/A	N/A	Gutter X Slope (%)	N/A
N/A	Painted X Walk1?	No	N/A	Painted X Walk2?	N/A
	X Walk 1 Direction	To SE		X Walk 2 Direction	N/A
N/A	X Walk 1 Width (in)	N/A	N/A	X Walk 2 Width (in)	N/A
	X Walk 1 Slope (%)	2.8		X Walk 2 Slope (%)	N/A
	X Walk 1 X Slope (%)	2.7		X Walk 2 X Slope (%)	N/A
N/A	Ramp inside XWalk1?	N/A	N/A	Ramp inside XWalk2?	N/A

Road Slope (%)	N/A	N/A	Clear Space?	N/A
	Road X Slope (%)	N/A	N/A	Clear Space to XWalk (in)	N/A
N/A	Any Obstructions?	N/A	N/A	Storm Grate/Utility Hazard?	N/A
	Obstruction Type			Storm Grate/Utility Type	
		N/A			N/A
			Yes	Surface Condition? (G/P)	Good
			N/A	Curb Slope (%)	0.3

Possible Solutions:

Remove & Replace Entire Ramp.

Total Cost: \$ 1600.00
