Access Compliance Report

Public Rights-of-Way

(Curb Ramps)

Intersection ID: 3514	Main Street: OVERLOOK_MOUNTAIN_DR	Cross Street: TRANQUILLITY_DR	Location: E
ADA ID: 3D5300FC2228	Ramp Type: BlendTrans1	Initial Pass/Fail: Pass	Overall Compliance: No
Severity Score: 0			
Codes/Mitigation Info/Possible Solution		Field Measurements/Component Compliance

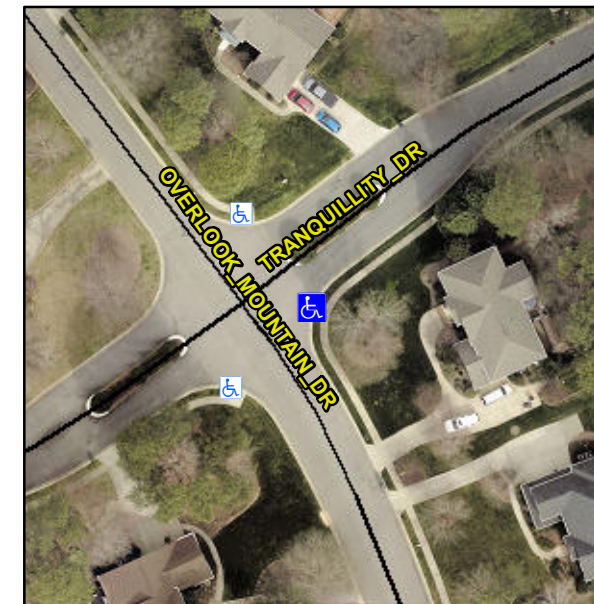
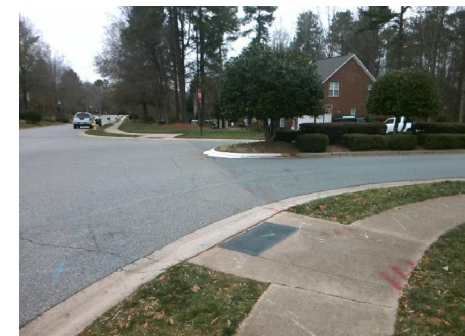
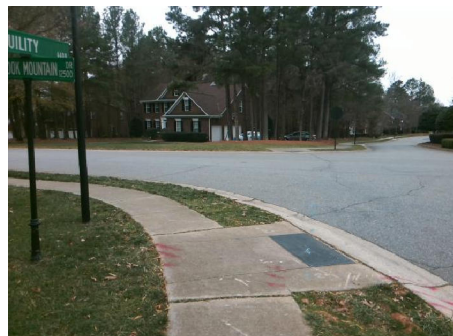
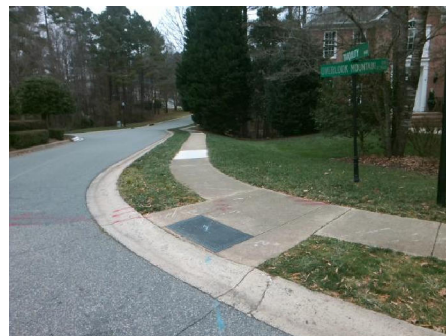
Not Found, R304.2.1, R304.2.2-Perp, R304.3.2-Para, R305.2

Compliance	Description	Data	Compliance	Description	Data
N/A	Ramp Length (in)	46.5	Yes	BlendTrans Slope (%)	4.2
Yes	Ramp Width (in)	48.0	Yes	BlendTrans XSlope (%)	0.5
N/A	Flare Type LT	Sloped	N/A	Flare Type RT	Sloped
N/A	Flare Slope LT (%)	5.0	N/A	Flare Slope RT (%)	6.2
N/A	Flare Traversable LT?	No	N/A	Flare Traversable RT?	No
Yes	Landing Length (in)	48.0	Yes	DWS Provided?	Yes
No	Landing Width (in)	47.5	Yes	DWS Contrast?	Yes
No	Landing Slope (%)	4.5	Yes	DWS Length (in)	25.0
Yes	Landing X Slope (%)	0.4	Yes	DWS Full Width?	Yes
N/A	Landing Curb? (Y/N)	No	No	DWS Offset (in)	3.5
N/A	Shared Landing?	No			
Yes	Gutter Ponding?	No	Yes	Gutter Slope (%)	4.8
Yes	Gutter Lip Ht (in)	0.0	Yes	Gutter X Slope (%)	0.7
N/A	Painted X Walk1?	No	N/A	Painted X Walk2?	No
	X Walk 1 Direction	To NW		X Walk 2 Direction	To SW
	X Walk 1 Width (in)	N/A		X Walk 2 Width (in)	N/A
	X Walk 1 Slope (%)	0.8		X Walk 2 Slope (%)	2.1
	X Walk 1 X Slope (%)	2.8		X Walk 2 X Slope (%)	1.4

N/A	Ramp inside XWalk1?	N/A	N/A	Ramp inside XWalk2?	N/A
	Road Slope (%)	0.6		Clear Space?	Yes
	Road X Slope (%)	2.3	N/A	Clear Space to XWalk (in)	N/A
Yes	Any Obstructions?	No	Yes	Storm Grate/Utility Hazard?	No
	Obstruction Type			Storm Grate/Utility Type	
		N/A			N/A
			Yes	Surface Condition? (G/P)	Good
			No	Curb Slope (%)	7.5

Remove & Replace Curb Ramp With Two New Directional Ramps or Equivalent.

Total Cost: \$ 3200.00
