# Access Compliance Report

## Public Rights-of-Way

### (Curb Ramps)

| Intersection ID: 26673 | Main Street: APPLE_TWIG_DR | Cross Street: WINTHROP_RIDGE_RD | Location: W |

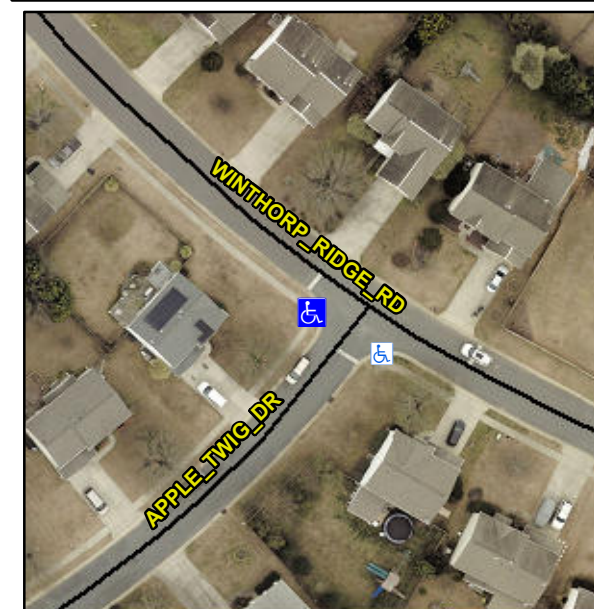
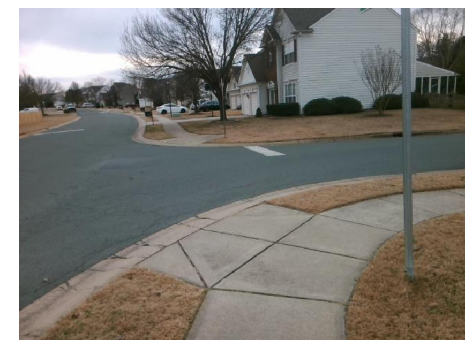
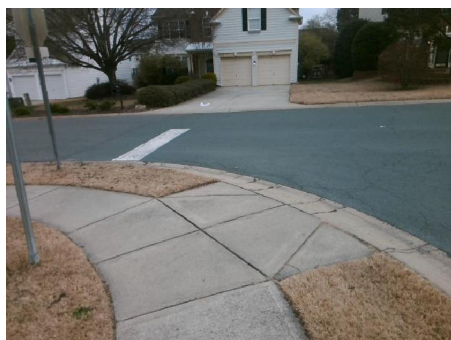
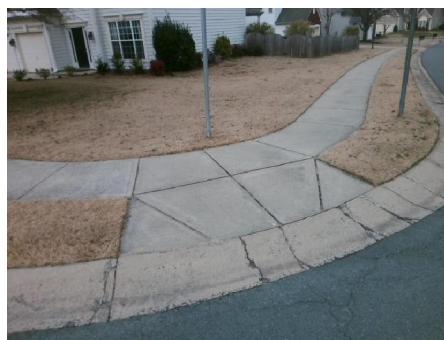
| ADA ID: 3D553F5022DD | Ramp Type: BlendTrans1 | Initial Pass/Fail: Fail | Overall Compliance: No |

| Severity Score: 8.75 | | | |

| Compliance | Description | Data | Compliance | Description | Data |
|---|---|---|---|---|---|
| No | Ramp Width (in) | 45.0 | Yes | BlendTrans XSlope (%) | 0.0 |

**Remove & Replace Curb Ramp With Two New Directional Ramps or Equivalent.**

**R304.5.1**
