Access Compliance Report

Public Rights-of-Way

(Curb Ramps)

Intersection ID: 14082	Main Street: OLD_STEELE_CREEK_RD	Cross Street: MARKLAND_DR	Location:	N
ADA ID: 3D5FF9A74E62	Ramp Type: PerpDiag	Initial Pass/Fail: Fail	Overall Compliance: No	Severity Score: 22.5
Codes/Mitigation Info/Possible Solution		Field Measurements/Component Compliance

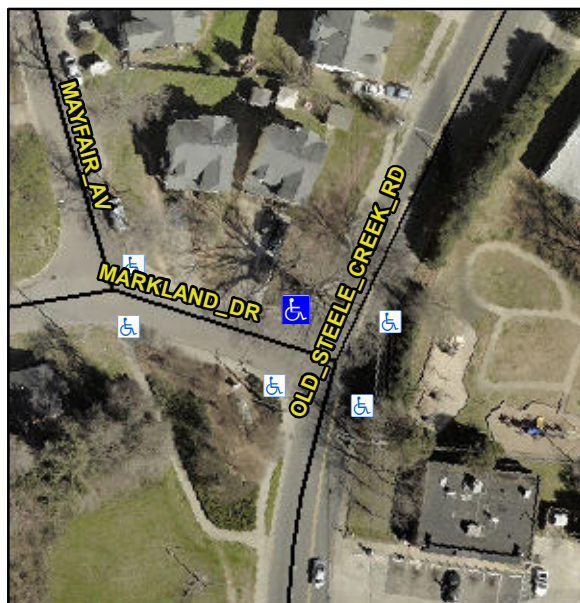
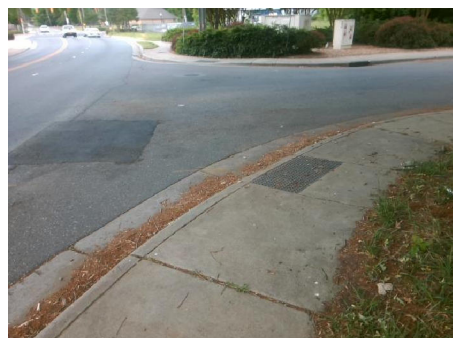
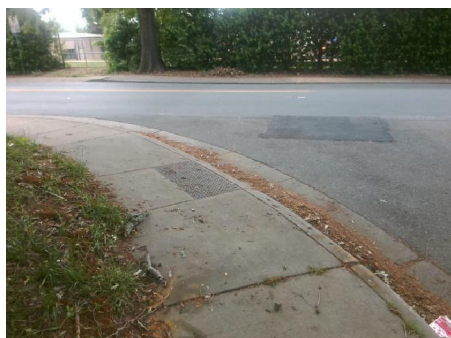
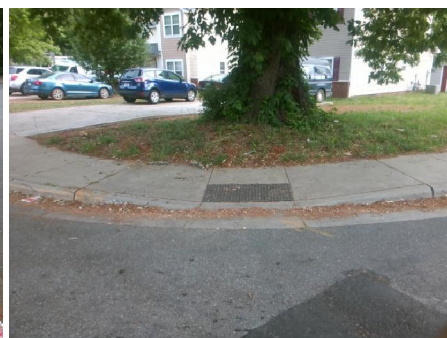
Not Found, R304.5.1, R304.2.2, R304.5.3

Compliance	Description	Data	Compliance	Description	Data
N/A	Ramp Length (in)	60.0	No	Ramp Slope (%)	11.8
No	Ramp Width (in)	46.0	No	Ramp XSlope (%)	2.6
N/A	Flare Type LT	N/A	N/A	Flare Type RT	N/A
N/A	Flare Slope LT (%)	N/A	N/A	Flare Slope RT (%)	N/A
N/A	Flare Traversable LT?	N/A	N/A	Flare Traversable RT?	N/A
N/A	Landing Length (in)	N/A	N/A	DWS Provided?	N/A
N/A	Landing Width (in)	N/A	N/A	DWS Contrast?	N/A
N/A	Landing Slope (%)	N/A	N/A	DWS Length (in)	N/A
N/A	Landing X Slope (%)	N/A	N/A	DWS Full Width?	N/A
N/A	Landing Curb? (Y/N)	N/A	N/A	DWS Offset (in)	N/A
N/A	Shared Landing?	N/A			
N/A	Gutter Ponding?	N/A	N/A	Gutter Slope (%)	N/A
N/A	Gutter Lip Ht (in)	N/A	N/A	Gutter X Slope (%)	N/A
N/A	Painted X Walk1?	No	N/A	Painted X Walk2?	No
	X Walk 1 Direction	To SW		X Walk 2 Direction	To SE
N/A	X Walk 1 Width (in)	N/A	N/A	X Walk 2 Width (in)	N/A
	X Walk 1 Slope (%)	1.1		X Walk 2 Slope (%)	1.7
	X Walk 1 X Slope (%)	0.2		X Walk 2 X Slope (%)	1.9

N/A	Ramp inside XWalk1?	N/A	N/A	Ramp inside XWalk2?	N/A
	Road Slope (%)	3.1	N/A	Clear Space?	N/A
	Road X Slope (%)	0.1	N/A	Clear Space to XWalk (in)	N/A
N/A	Any Obstructions?	N/A	N/A	Storm Grate/Utility Hazard?	N/A
	Obstruction Type			Storm Grate/Utility Type	
		N/A			N/A
			Yes	Surface Condition? (G/P)	Good

Remove & Replace Curb Ramp With Two New Directional Ramps or Equivalent.
