Access Compliance Report

Public Rights-of-Way

(Curb Ramps)

Intersection ID: 42666	Main Street: WALLACE_GLEN_DR	Cross Street: MUSKOGEE_DR	Location: S
ADA ID: 3D65EFBB641F	Ramp Type: PerpDiag	Initial Pass/Fail: Fail	Overall Compliance: No
Codes/Mitigation Info/Possible Solution		Field Measurements/Component Compliance	
Severity Score: 8.75

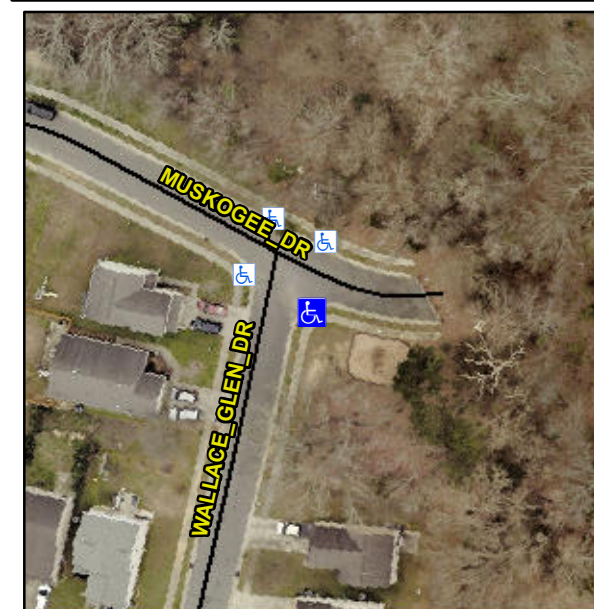
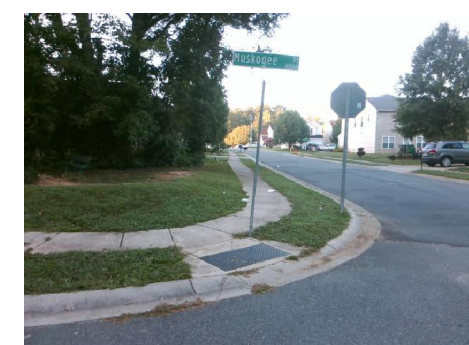
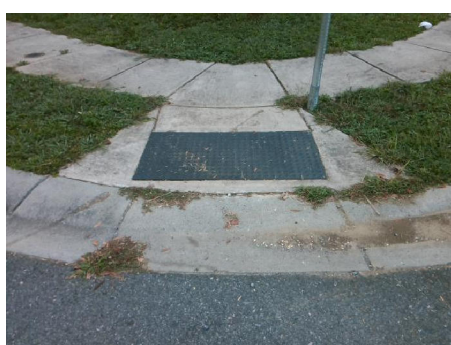
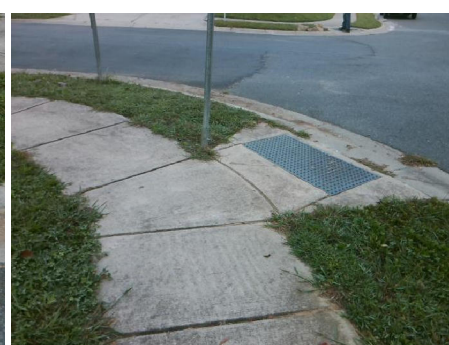
Not Found, R304.5.1

Compliance	Description	Data	Compliance	Description	Data
N/A	Ramp Length (in)	48.0	Yes	Ramp Slope (%)	5.7
No	Ramp Width (in)	45.5	Yes	Ramp XSlope (%)	1.7
N/A	Flare Type LT	N/A	N/A	Flare Type RT	N/A
N/A	Flare Slope LT (%)	N/A	N/A	Flare Slope RT (%)	N/A
N/A	Flare Traversable LT?	N/A	N/A	Flare Traversable RT?	N/A
N/A	Landing Length (in)	N/A	N/A	DWS Provided?	N/A
N/A	Landing Width (in)	N/A	N/A	DWS Contrast?	N/A
N/A	Landing Slope (%)	N/A	N/A	DWS Length (in)	N/A
N/A	Landing X Slope (%)	N/A	N/A	DWS Full Width?	N/A
N/A	Landing Curb? (Y/N)	N/A	N/A	DWS Offset (in)	N/A
N/A	Shared Landing?	N/A			
N/A	Gutter Ponding?	N/A	N/A	Gutter Slope (%)	N/A
N/A	Gutter Lip Ht (in)	N/A	N/A	Gutter X Slope (%)	N/A
N/A	Painted X Walk1?	No	N/A	Painted X Walk2?	No
	X Walk 1 Direction	To NE		X Walk 2 Direction	To NW
N/A	X Walk 1 Width (in)	N/A	N/A	X Walk 2 Width (in)	N/A
	X Walk 1 Slope (%)	0.9		X Walk 2 Slope (%)	1.8
	X Walk 1 X Slope (%)	1.6		X Walk 2 X Slope (%)	0.9

N/A	Ramp inside XWalk1?	N/A	N/A	Ramp inside XWalk2?	N/A
	Road Slope (%)	3.5	N/A	Clear Space?	N/A
	Road X Slope (%)	0.5	N/A	Clear Space to XWalk (in)	N/A
N/A	Any Obstructions?	N/A	N/A	Storm Grate/Utility Hazard?	N/A
	Obstruction Type			Storm Grate/Utility Type	
		N/A			N/A
			Yes	Surface Condition? (G/P)	Good

Remove & Replace Curb Ramp With Two New Directional Ramps or Equivalent.
