Access Compliance Report

Public Rights-of-Way

(Curb Ramps)

Intersection ID: 22279	Main Street: COLONY_RD	Cross Street: LORI_LN	Location: SE
ADA ID: 3D74EF8B662A	Ramp Type: Perp	Initial Pass/Fail: Fail	Overall Compliance: No
Severity Score: 13.75			
Codes/Mitigation Info/Possible Solution		Field Measurements/Component Compliance

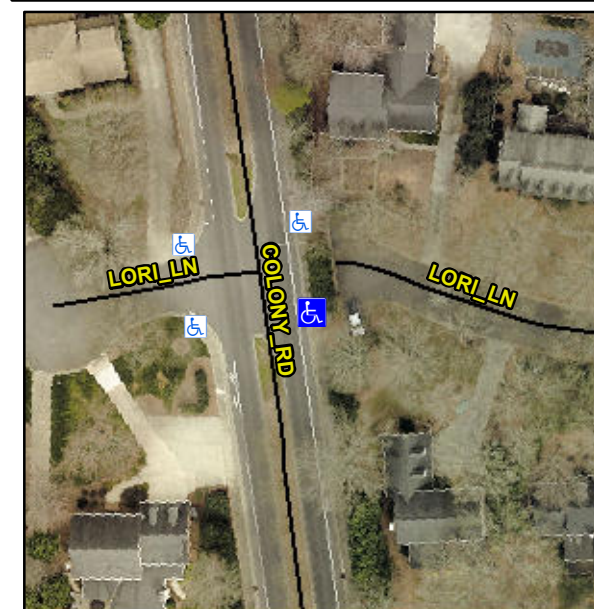
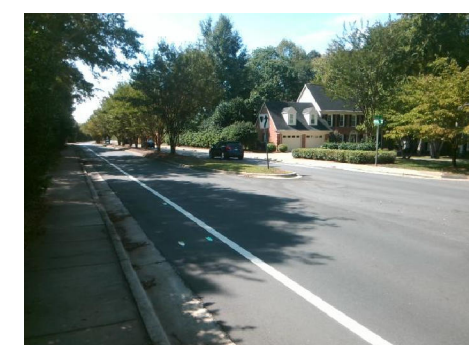
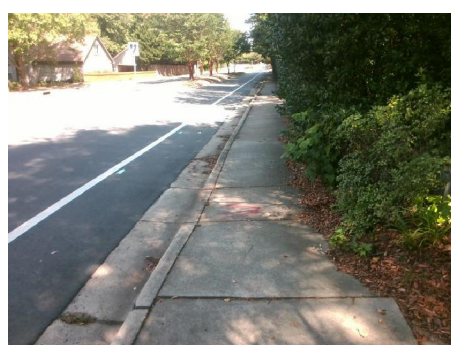
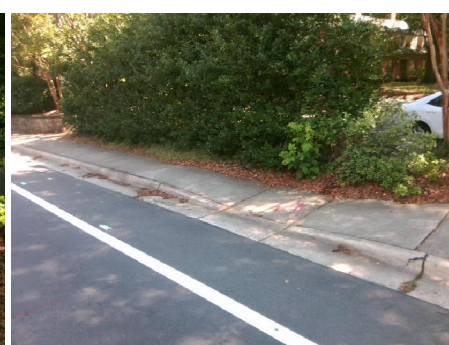
Not Found, R304.2.2, R304.5.3

Compliance	Description	Data	Compliance	Description	Data
N/A	Ramp Length (in)	64.0	No	Ramp Slope (%)	9.8
Yes	Ramp Width (in)	49.0	No	Ramp XSlope (%)	2.6
N/A	Flare Type LT	N/A	N/A	Flare Type RT	N/A
N/A	Flare Slope LT (%)	N/A	N/A	Flare Slope RT (%)	N/A
N/A	Flare Traversable LT?	N/A	N/A	Flare Traversable RT?	N/A
N/A	Landing Length (in)	N/A	N/A	DWS Provided?	N/A
N/A	Landing Width (in)	N/A	N/A	DWS Contrast?	N/A
N/A	Landing Slope (%)	N/A	N/A	DWS Length (in)	N/A
N/A	Landing X Slope (%)	N/A	N/A	DWS Full Width?	N/A
N/A	Landing Curb? (Y/N)	N/A	N/A	DWS Offset (in)	N/A
N/A	Shared Landing?	N/A			
N/A	Gutter Ponding?	N/A	N/A	Gutter Slope (%)	N/A
N/A	Gutter Lip Ht (in)	N/A	N/A	Gutter X Slope (%)	N/A
N/A	Painted X Walk1?	No	N/A	Painted X Walk2?	N/A
	X Walk 1 Direction	To W		X Walk 2 Direction	N/A
N/A	X Walk 1 Width (in)	N/A	N/A	X Walk 2 Width (in)	N/A
	X Walk 1 Slope (%)	1.9		X Walk 2 Slope (%)	N/A
	X Walk 1 X Slope (%)	0.6		X Walk 2 X Slope (%)	N/A

N/A	Ramp inside XWalk1?	N/A	N/A	Ramp inside XWalk2?	N/A
	Road Slope (%)	N/A	N/A	Clear Space?	N/A
	Road X Slope (%)	N/A	N/A	Clear Space to XWalk (in)	N/A
N/A	Any Obstructions?	N/A	N/A	Storm Grate/Utility Hazard?	N/A
	Obstruction Type			Storm Grate/Utility Type	
		N/A			N/A
			Yes	Surface Condition? (G/P)	Good

Remove & Replace Entire Ramp.
