# Access Compliance Report

## Public Rights-of-Way

### (Curb Ramps)

Intersection ID: 44689	Main Street: SHANON DARBY LN	Cross Street: GENTLE STREAM LN	Location: NW
ADA ID: 3D7F028D1A21	Ramp Type: PerpDiag	Initial Pass/Fail: Fail	Overall Compliance: No
		Severity Score: 8.75

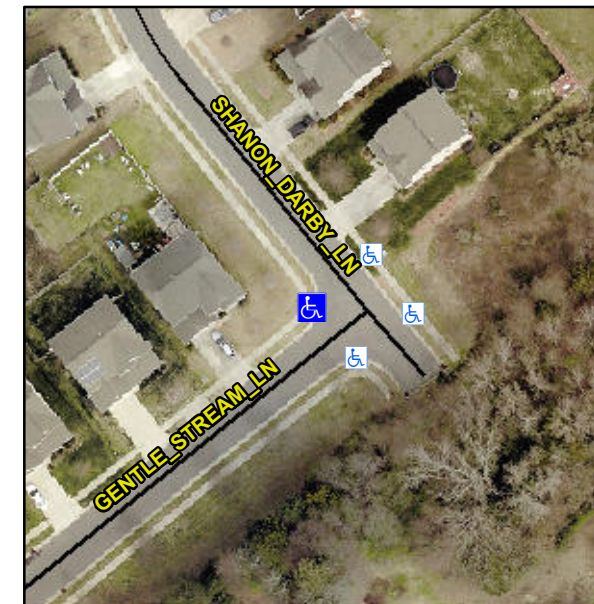
**Not Found, R304.5.1**

Compliance	Description	Data	Compliance	Description	Data
N/A	Ramp Length (in)	48.0	Yes	Ramp Slope (%)	7.8
No	Ramp Width (in)	47.5	Yes	Ramp XSlope (%)	1.1
N/A	Flare Type LT	N/A	N/A	Flare Type RT	N/A
N/A	Flare Slope LT (%)	N/A	N/A	Flare Slope RT (%)	N/A
N/A	Flare Traversable LT?	N/A	N/A	Flare Traversable RT?	N/A
N/A	Landing Length (in)	N/A	N/A	DWS Provided?	N/A
N/A	Landing Width (in)	N/A	N/A	DWS Contrast?	N/A
N/A	Landing Slope (%)	N/A	N/A	DWS Length (in)	N/A
N/A	Landing X Slope (%)	N/A	N/A	DWS Full Width?	N/A
N/A	Landing Curb? (Y/N)	N/A	N/A	DWS Offset (in)	N/A
N/A	Shared Landing?	N/A			
N/A	Gutter Ponding?	N/A	N/A	Gutter Slope (%)	N/A
N/A	Gutter Lip Ht (in)	N/A	N/A	Gutter X Slope (%)	N/A
N/A	Painted X Walk1?	No	N/A	Painted X Walk2?	No
	X Walk 1 Direction	To SE		X Walk 2 Direction	To NE
N/A	X Walk 1 Width (in)	N/A	N/A	X Walk 2 Width (in)	N/A
	X Walk 1 Slope (%)	0.6		X Walk 2 Slope (%)	1.0
	X Walk 1 X Slope (%)	0.4		X Walk 2 X Slope (%)	1.9

N/A	Ramp inside XWalk1?	N/A	N/A	Ramp inside XWalk2?	N/A
	Road Slope (%)	1.0	N/A	Clear Space?	N/A
	Road X Slope (%)	0.9	N/A	Clear Space to XWalk (in)	N/A
N/A	Any Obstructions?	N/A	N/A	Storm Grate/Utility Hazard?	N/A
	Obstruction Type			Storm Grate/Utility Type	
		N/A			N/A
			Yes	Surface Condition? (G/P)	Good

**Remove & Replace Curb Ramp With Two New Directional Ramps or Equivalent.**
