# Access Compliance Report

## Public Rights-of-Way

| Intersection ID: 27432 | Main Street: BALLANTYNE COMMONS PY | Cross Street: DURANT BV | Location: | SW |
| ADA ID: 3D819738E31A | Ramp Type: BlendTrans1 | Initial Pass/Fail: Fail | Overall Compliance: No | Severity Score: 25 |

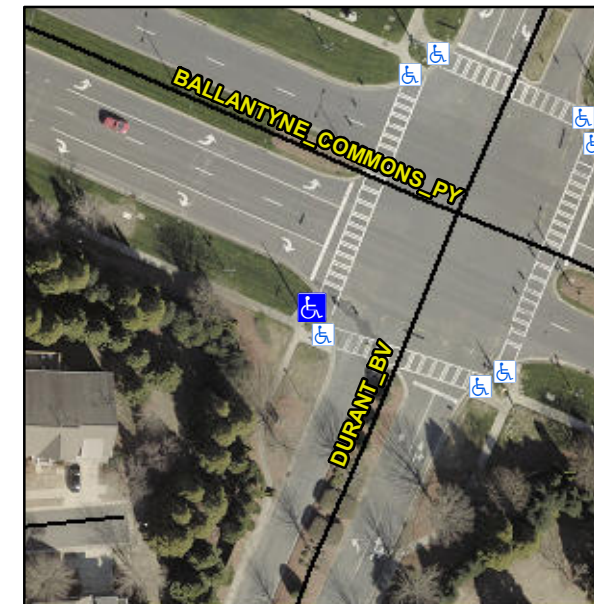
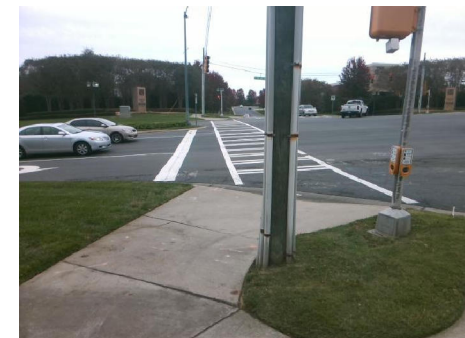
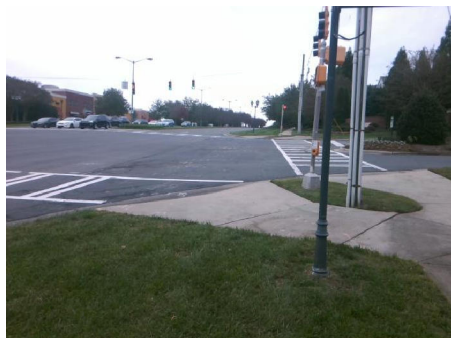
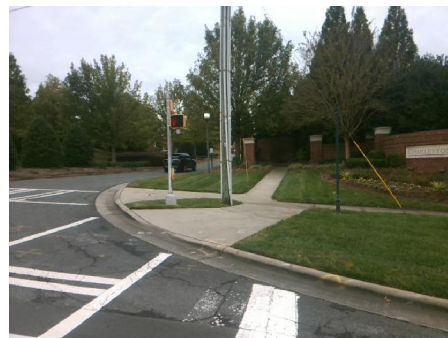
**Not Found, R304.5.3**

| Compliance | Description | Data | Compliance | Description | Data |
|---|---|---|---|---|---|
| Yes | Ramp Width (in) | 48.0 | No | BlendTrans XSlope (%) | 10.1 |
| | | | No | Curb Slope (%) | 20.3 |

**Remove & Replace Curb Ramp With Two New Directional Ramps or Equivalent.**

Total Cost: \$ 3200.00
