# Access Compliance Report

## Public Rights-of-Way

### (Curb Ramps)

Intersection ID: 10019976	Main Street: ARENA_BV	Cross Street: N/A	Location: NW
ADA ID: 3D829D1BA078	Ramp Type: PerpDiag	Initial Pass/Fail: Fail	Overall Compliance: No
		Severity Score: 12.5

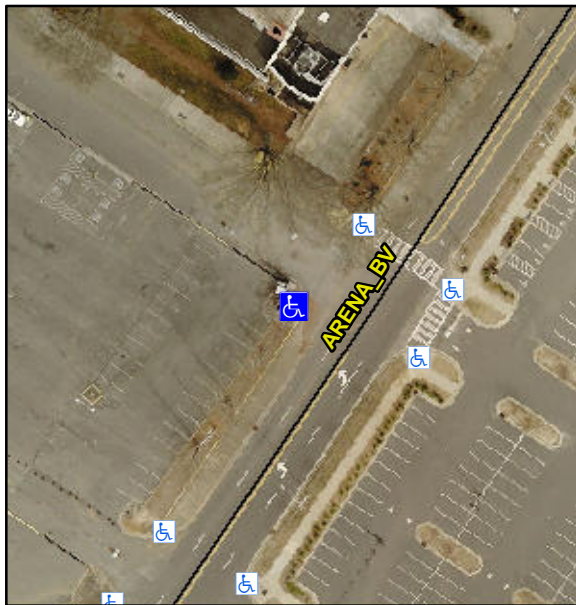
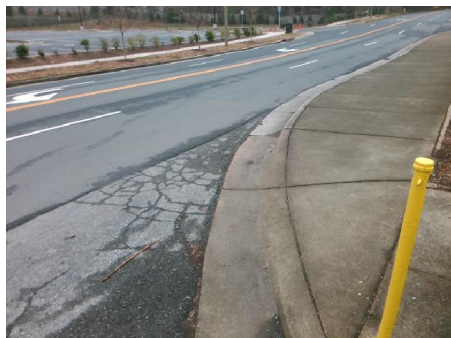
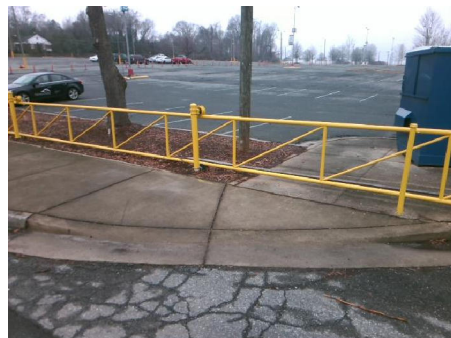
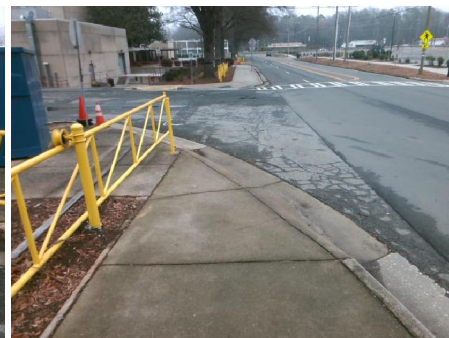
**Not Found, R304.2.2**

Compliance	Description	Data	Compliance	Description	Data
N/A	Ramp Length (in)	58.0	No	Ramp Slope (%)	11.7
Yes	Ramp Width (in)	96.0	Yes	Ramp XSlope (%)	1.9
N/A	Flare Type LT	N/A	N/A	Flare Type RT	N/A
N/A	Flare Slope LT (%)	N/A	N/A	Flare Slope RT (%)	N/A
N/A	Flare Traversable LT?	N/A	N/A	Flare Traversable RT?	N/A
N/A	Landing Length (in)	N/A	N/A	DWS Provided?	N/A
N/A	Landing Width (in)	N/A	N/A	DWS Contrast?	N/A
N/A	Landing Slope (%)	N/A	N/A	DWS Length (in)	N/A
N/A	Landing X Slope (%)	N/A	N/A	DWS Full Width?	N/A
N/A	Landing Curb? (Y/N)	N/A	N/A	DWS Offset (in)	N/A
N/A	Shared Landing?	N/A			
N/A	Gutter Ponding?	N/A	N/A	Gutter Slope (%)	N/A
N/A	Gutter Lip Ht (in)	N/A	N/A	Gutter X Slope (%)	N/A
N/A	Painted X Walk1?	No	N/A	Painted X Walk2?	No
	X Walk 1 Direction	To SE		X Walk 2 Direction	To NE
N/A	X Walk 1 Width (in)	N/A	N/A	X Walk 2 Width (in)	N/A
	X Walk 1 Slope (%)	1.7		X Walk 2 Slope (%)	3.1
	X Walk 1 X Slope (%)	2.8		X Walk 2 X Slope (%)	2.3

N/A	Ramp inside XWalk1?	N/A	N/A	Ramp inside XWalk2?	N/A
	Road Slope (%)	0.3	N/A	Clear Space?	N/A
	Road X Slope (%)	1.6	N/A	Clear Space to XWalk (in)	N/A
N/A	Any Obstructions?	N/A	N/A	Storm Grate/Utility Hazard?	N/A
	Obstruction Type			Storm Grate/Utility Type	
		N/A			N/A
			Yes	Surface Condition? (G/P)	Good

**Remove & Replace Curb Ramp With Two New Directional Ramps or Equivalent.**
