# Access Compliance Report

## Public Rights-of-Way

### (Curb Ramps)

Intersection ID: N/A	Main Street: BRYANT_FARMS_RD	Cross Street: KINGSTON_FOREST_DR	Location: SW
ADA ID: 3D86C021D30F	Ramp Type: PerpDiag	Initial Pass/Fail: Pass	Overall Compliance: No
		Severity Score: 0

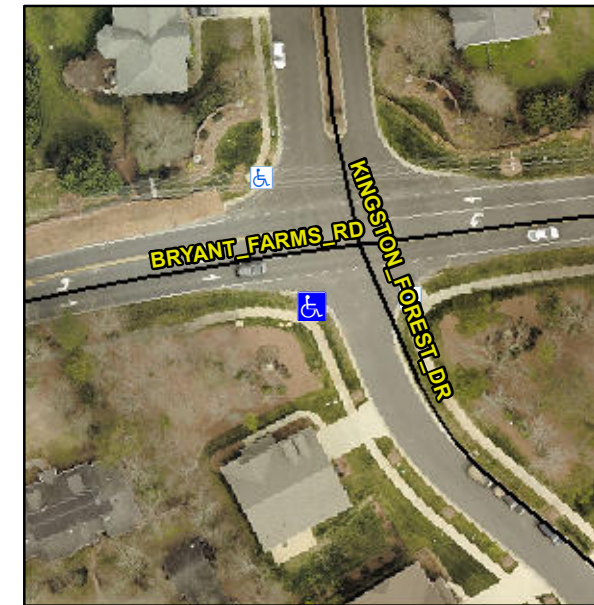
Compliance	Description	Data	Compliance	Description	Data
N/A	Ramp Length (in)	97.0	Yes	Ramp Slope (%)	5.8
Yes	Ramp Width (in)	60.0	Yes	Ramp XSlope (%)	0.5
N/A	Flare Type LT	Sloped	N/A	Flare Type RT	N/A
N/A	Flare Slope LT (%)	2.6	Yes	Flare Slope RT (%)	6.7
N/A	Flare Traversable LT?	Yes	N/A	Flare Traversable RT?	Yes
Yes	Landing Length (in)	59.0	Yes	DWS Provided?	Yes
Yes	Landing Width (in)	60.0	Yes	DWS Contrast?	Yes
Yes	Landing Slope (%)	1.1	Yes	DWS Length (in)	24.0
Yes	Landing X Slope (%)	1.3	Yes	DWS Full Width?	Yes
N/A	Landing Curb? (Y/N)	No	No	DWS Offset (in)	3.0
N/A	Shared Landing?	No			
Yes	Gutter Ponding?	No	Yes	Gutter Slope (%)	3.6
Yes	Gutter Lip Ht (in)	0.0	Yes	Gutter X Slope (%)	1.3
N/A	Painted X Walk1?	No	N/A	Painted X Walk2?	No
	X Walk 1 Direction	To E		X Walk 2 Direction	To N
N/A	X Walk 1 Width (in)	N/A	N/A	X Walk 2 Width (in)	N/A
	X Walk 1 Slope (%)	2.8		X Walk 2 Slope (%)	5.1
	X Walk 1 X Slope (%)	3.0		X Walk 2 X Slope (%)	0.0

N/A	Ramp inside XWalk1?	N/A	N/A	Ramp inside XWalk2?	N/A
	Road Slope (%)	2.0	N/A	Clear Space?	Yes
	Road X Slope (%)	4.2	N/A	Clear Space to XWalk (in)	N/A
Yes	Any Obstructions?	No	Yes	Storm Grate/Utility Hazard?	No
	Obstruction Type			Storm Grate/Utility Type	
		N/A			N/A
			Yes	Surface Condition? (G/P)	Good

**Remove & Replace Detectable Warning System.**

**R305.2**

**\$ 800.00**
