## Access Compliance Report Public Rights-of-Way (Curb Ramps)

Intersection ID: 8153Main Street:CINDERELLA\_RDCross Street:W\_SUGAR\_CREEK\_RDLocation:NEADA ID: 3D89B61AE2D1Ramp Type:ParaDiagInitial Pass/Fail:FailOverall Compliance:NoSeverity Score:25

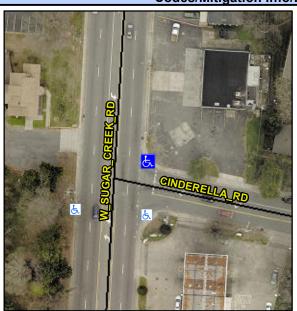
RT RP < 5%, VEGETATION OVERGROWTH

Compliance         Description         Data         Compliance         Description           N/A         Ramp Length LT (in)         51.0         N/A         Ramp Length RT (in)           Yes         Ramp Width LT (in)         59.0         Yes         Ramp Width RT (in)           No         Ramp Slope LT (%)         12.4         Yes         Ramp Slope RT (%)	0.3 0.8 N/A
Yes Ramp Width LT (in) 59.0 Yes Ramp Width RT (in)	60.0 0.3 0.8

0.3 0.8
NO Ramp Slope LI (%) 12.4 Yes Ramp Slope RI (%)	0.8
Yes Ramp XSlope LT (%) 0.8 Yes Ramp XSlope RT (%)	N/A
N/A Landing Length (in) N/A N/A DWS Provided?	
N/A Landing Width (in) N/A N/A DWS Contrast?	N/A
N/A Landing Slope (%) N/A N/A DWS Length (in)	N/A
N/A Landing X Slope (%) N/A N/A DWS Full Width?	N/A
N/A Landing Curb? (Y/N) N/A N/A DWS Offset (in)	N/A
N/A Shared Landing? N/A	
N/A Gutter Ponding? N/A N/A Gutter Slope (%)	N/A
N/A Gutter Lip Ht (in) N/A N/A Gutter X Slope (%)	N/A
N/A Painted X Walk1? No N/A Painted X Walk2?	No
X Walk 1 Direction To W X Walk 2 Direction	To S
N/A X Walk 1 Width (in) N/A N/A X Walk 2 Width (in)	N/A
X Walk 1 Slope (%) 1.9 X Walk 2 Slope (%)	1.5
X Walk 1 X Slope (%) 2.8 X Walk 2 X Slope (%)	5.1
N/A Ramp inside XWalk1? N/A Ramp inside XWalk2?	N/A
Road Slope (%) 6.3 N/A Clear Space?	N/A
Road X Slope (%) 1.9 N/A Clear Space to XWalk (in)	N/A
N/A Any Obstructions? N/A N/A Storm Grate/Utility Hazard?	N/A

Remove & Replace Curb Ramp With Two New Directional Ramps or Equivalent.
