Access Compliance Report

Public Rights-of-Way

(Curb Ramps)

Intersection ID: 6068	Main Street: CATHEY_RD	Cross Street: COULWOOD_DR	Location: S
ADA ID: 3D8FAE1A6A29	Ramp Type: Perp	Initial Pass/Fail: Fail	Overall Compliance: No
Codes/Mitigation Info/Possible Solution		Field Measurements/Component Compliance	
Severity Score: 33.75

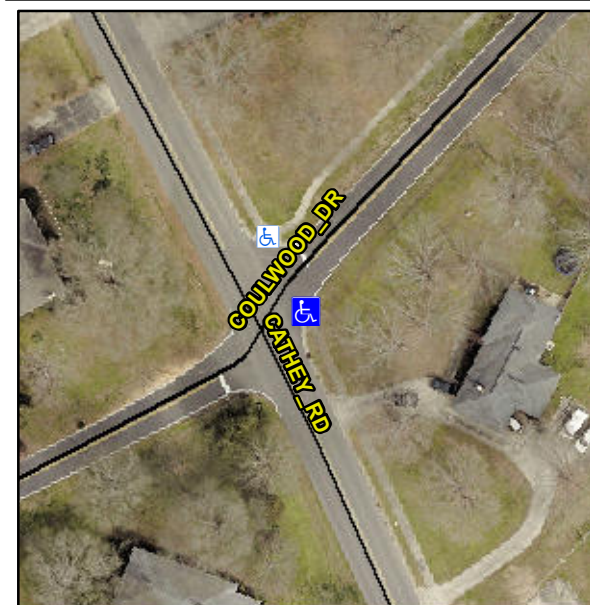
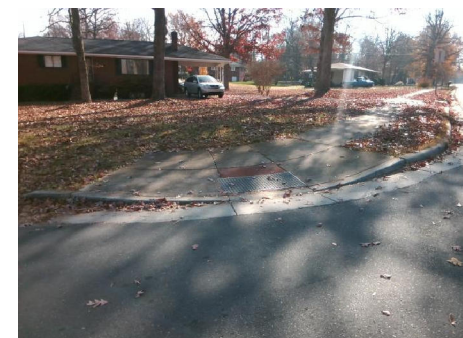
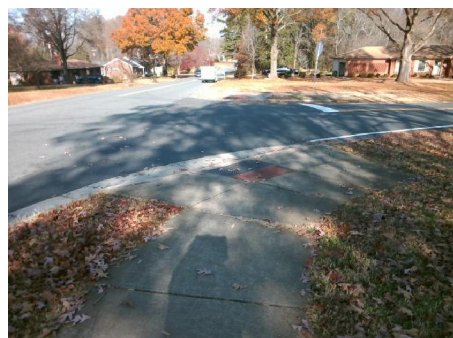
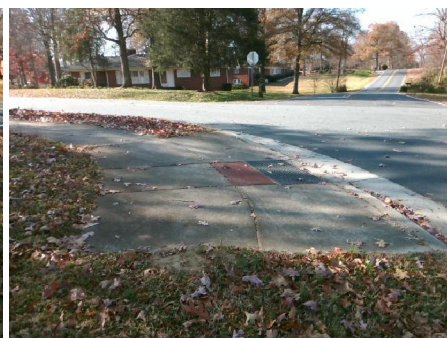
Not Found, R304.5.1, R304.2.2, R304.5.3

Compliance	Description	Data	Compliance	Description	Data
N/A	Ramp Length (in)	48.5	No	Ramp Slope (%)	8.6
No	Ramp Width (in)	40.5	No	Ramp XSlope (%)	5.5
N/A	Flare Type LT	N/A	N/A	Flare Type RT	N/A
N/A	Flare Slope LT (%)	N/A	N/A	Flare Slope RT (%)	N/A
N/A	Flare Traversable LT?	N/A	N/A	Flare Traversable RT?	N/A
N/A	Landing Length (in)	N/A	N/A	DWS Provided?	N/A
N/A	Landing Width (in)	N/A	N/A	DWS Contrast?	N/A
N/A	Landing Slope (%)	N/A	N/A	DWS Length (in)	N/A
N/A	Landing X Slope (%)	N/A	N/A	DWS Full Width?	N/A
N/A	Landing Curb? (Y/N)	N/A	N/A	DWS Offset (in)	N/A
N/A	Shared Landing?	N/A			
N/A	Gutter Ponding?	N/A	N/A	Gutter Slope (%)	N/A
N/A	Gutter Lip Ht (in)	N/A	N/A	Gutter X Slope (%)	N/A
N/A	Painted X Walk1?	No	N/A	Painted X Walk2?	N/A
	X Walk 1 Direction	To N		X Walk 2 Direction	N/A
N/A	X Walk 1 Width (in)	N/A	N/A	X Walk 2 Width (in)	N/A
	X Walk 1 Slope (%)	0.7		X Walk 2 Slope (%)	N/A
	X Walk 1 X Slope (%)	3.2		X Walk 2 X Slope (%)	N/A

N/A	Ramp inside XWalk1?	N/A	N/A	Ramp inside XWalk2?	N/A
	Road Slope (%)	N/A	N/A	Clear Space?	N/A
	Road X Slope (%)	N/A	N/A	Clear Space to XWalk (in)	N/A
N/A	Any Obstructions?	N/A	N/A	Storm Grate/Utility Hazard?	N/A
	Obstruction Type			Storm Grate/Utility Type	
		N/A			N/A
			Yes	Surface Condition? (G/P)	Good

Remove & Replace Entire Ramp.
