Access Compliance Report

Public Rights-of-Way

(Curb Ramps)

Intersection ID: N/A	Main Street: ALLEGIANCE DR	Cross Street: TANYARD LN	Location: W
ADA ID: 3D9ECA0940AA	Ramp Type: PerpDiag	Initial Pass/Fail: Fail	Overall Compliance: No
Codes/Mitigation Info/Possible Solution		Field Measurements/Component Compliance	
Severity Score: 10

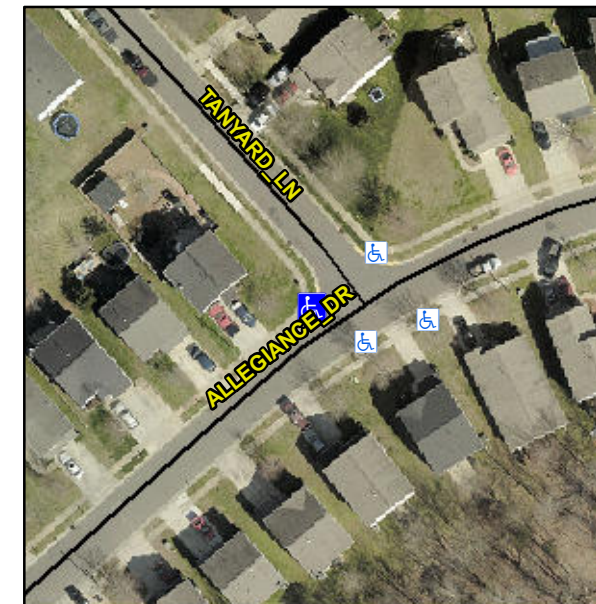
Not Found, R304.5.1, R304.5.3

Compliance	Description	Data	Compliance	Description	Data
N/A	Ramp Length (in)	48.0	Yes	Ramp Slope (%)	7.8
No	Ramp Width (in)	37.0	No	Ramp XSlope (%)	4.4
N/A	Flare Type LT	N/A	N/A	Flare Type RT	N/A
N/A	Flare Slope LT (%)	N/A	N/A	Flare Slope RT (%)	N/A
N/A	Flare Traversable LT?	No	N/A	Flare Traversable RT?	No
N/A	Landing Length (in)	N/A	N/A	DWS Provided?	N/A
N/A	Landing Width (in)	N/A	N/A	DWS Contrast?	N/A
N/A	Landing Slope (%)	N/A	N/A	DWS Length (in)	N/A
N/A	Landing X Slope (%)	N/A	N/A	DWS Full Width?	N/A
N/A	Landing Curb? (Y/N)	N/A	N/A	DWS Offset (in)	N/A
N/A	Shared Landing?	N/A			
N/A	Gutter Ponding?	N/A	N/A	Gutter Slope (%)	N/A
N/A	Gutter Lip Ht (in)	N/A	N/A	Gutter X Slope (%)	N/A
N/A	Painted X Walk1?	No	N/A	Painted X Walk2?	No
	X Walk 1 Direction	To SE		X Walk 2 Direction	To NE
N/A	X Walk 1 Width (in)	N/A	N/A	X Walk 2 Width (in)	N/A
	X Walk 1 Slope (%)	1.0		X Walk 2 Slope (%)	3.3
	X Walk 1 X Slope (%)	3.5		X Walk 2 X Slope (%)	3.4

N/A	Ramp inside XWalk1?	No	N/A	Ramp inside XWalk2?	No
	Road Slope (%)	3.5	N/A	Clear Space?	N/A
	Road X Slope (%)	0.2	N/A	Clear Space to XWalk (in)	N/A
N/A	Any Obstructions?	N/A	N/A	Storm Grate/Utility Hazard?	N/A
	Obstruction Type			Storm Grate/Utility Type	
		N/A			N/A
			Yes	Surface Condition? (G/P)	Good

Possible Solutions:

Remove & Replace Curb Ramp With Two New Directional Ramps or Equivalent.
