# Access Compliance Report

## Public Rights-of-Way

### (Curb Ramps)

Intersection ID: 51358	Main Street: PIKE_RD	Cross Street: BRENTMOOR_DR	Location: SW
ADA ID: 3DA05CDCD99A	Ramp Type: BlendTrans1	Initial Pass/Fail: Pass	Overall Compliance: No
		Severity Score: 0

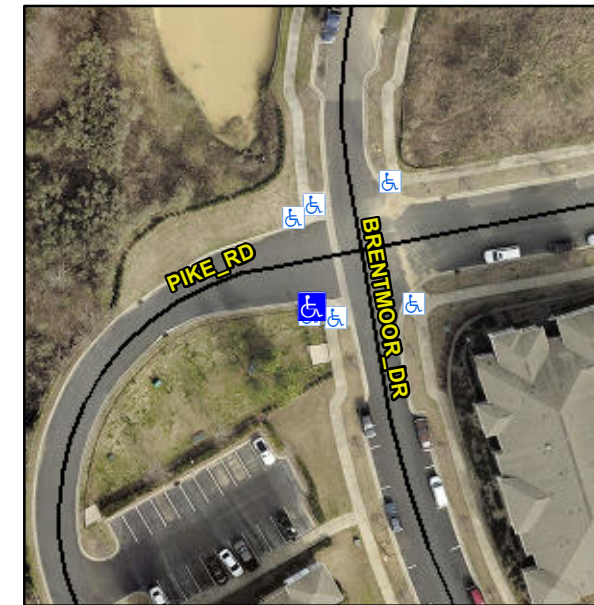
Compliance	Description	Data	Compliance	Description	Data
N/A	Ramp Length (in)	73.0	Yes	BlendTrans Slope (%)	3.0
Yes	Ramp Width (in)	48.0	Yes	BlendTrans XSlope (%)	1.4
N/A	Flare Type LT	Sloped	N/A	Flare Type RT	Sloped
N/A	Flare Slope LT (%)	5.0	N/A	Flare Slope RT (%)	5.6
N/A	Flare Traversable LT?	No	N/A	Flare Traversable RT?	No
No	Landing Length (in)	44.0	Yes	DWS Provided?	Yes
Yes	Landing Width (in)	48.0	Yes	DWS Contrast?	Yes
Yes	Landing Slope (%)	0.1	Yes	DWS Length (in)	24.0
Yes	Landing X Slope (%)	0.6	Yes	DWS Full Width?	Yes
N/A	Landing Curb? (Y/N)	No	Yes	DWS Offset (in)	1.5
N/A	Shared Landing?	No			
Yes	Gutter Ponding?	No	Yes	Gutter Slope (%)	1.1
Yes	Gutter Lip Ht (in)	0.0	Yes	Gutter X Slope (%)	0.2
N/A	Painted X Walk1?	No	N/A	Painted X Walk2?	N/A
	X Walk 1 Direction	To N		X Walk 2 Direction	N/A
	X Walk 1 Width (in)	N/A		X Walk 2 Width (in)	N/A
	X Walk 1 Slope (%)	2.7		X Walk 2 Slope (%)	N/A
	X Walk 1 X Slope (%)	1.3		X Walk 2 X Slope (%)	N/A

N/A	Ramp inside XWalk1?	N/A	N/A	Ramp inside XWalk2?	N/A
	Road Slope (%)	1.3		Clear Space?	Yes
	Road X Slope (%)	2.7	N/A	Clear Space to XWalk (in)	N/A
Yes	Any Obstructions?	No	Yes	Storm Grate/Utility Hazard?	No
	Obstruction Type			Storm Grate/Utility Type	
			N/A		N/A
			Yes	Surface Condition? (G/P)	Good
			N/A	Curb Slope (%)	N/A

Possible Solutions:

**Remove & Replace Landing.**

PROW/ADA:

**R304.2.1**

Total Cost:

\$ 500.00
