Access Compliance Report

Public Rights-of-Way

(Curb Ramps)

Intersection ID: 5966	Main Street: SUNSTONE_DR	Cross Street: STATESVILLE_RD	Location: NW
ADA ID: 3DA798F7BCAC	Ramp Type: Perp	Initial Pass/Fail: Fail	Overall Compliance: No
Severity Score: 21.25			
Codes/Mitigation Info/Possible Solution		Field Measurements/Component Compliance

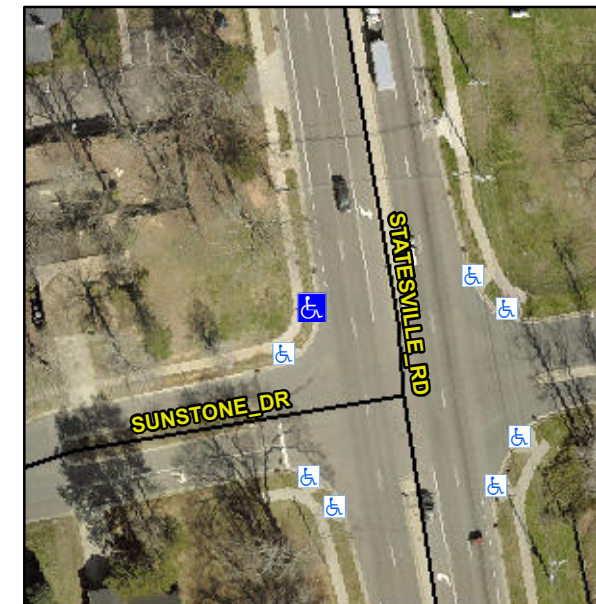
Not Found, R304.5.1, R304.2.2

Compliance	Description	Data	Compliance	Description	Data
N/A	Ramp Length (in)	72.0	No	Ramp Slope (%)	9.5
No	Ramp Width (in)	47.0	Yes	Ramp XSlope (%)	1.2
N/A	Flare Type LT	N/A	N/A	Flare Type RT	N/A
N/A	Flare Slope LT (%)	N/A	N/A	Flare Slope RT (%)	N/A
N/A	Flare Traversable LT?	N/A	N/A	Flare Traversable RT?	N/A
N/A	Landing Length (in)	N/A	N/A	DWS Provided?	N/A
N/A	Landing Width (in)	N/A	N/A	DWS Contrast?	N/A
N/A	Landing Slope (%)	N/A	N/A	DWS Length (in)	N/A
N/A	Landing X Slope (%)	N/A	N/A	DWS Full Width?	N/A
N/A	Landing Curb? (Y/N)	N/A	N/A	DWS Offset (in)	N/A
N/A	Shared Landing?	N/A			
N/A	Gutter Ponding?	N/A	N/A	Gutter Slope (%)	N/A
N/A	Gutter Lip Ht (in)	N/A	N/A	Gutter X Slope (%)	N/A
N/A	Painted X Walk1?	No	N/A	Painted X Walk2?	N/A
	X Walk 1 Direction	To E		X Walk 2 Direction	N/A
N/A	X Walk 1 Width (in)	N/A	N/A	X Walk 2 Width (in)	N/A
	X Walk 1 Slope (%)	2.3		X Walk 2 Slope (%)	N/A
	X Walk 1 X Slope (%)	0.1		X Walk 2 X Slope (%)	N/A

N/A	Ramp inside XWalk1?	N/A	N/A	Ramp inside XWalk2?	N/A
	Road Slope (%)	N/A	N/A	Clear Space?	N/A
	Road X Slope (%)	N/A	N/A	Clear Space to XWalk (in)	N/A
N/A	Any Obstructions?	N/A	N/A	Storm Grate/Utility Hazard?	N/A
	Obstruction Type			Storm Grate/Utility Type	
		N/A			N/A
			Yes	Surface Condition? (G/P)	Good

Possible Solutions:

Remove & Replace Entire Ramp.
