Access Compliance Report

Public Rights-of-Way

(Curb Ramps)

Intersection ID: 3670	Main Street: APPALOOSA_WAY_LN	Cross Street: CLAIBORNE_WOODS_RD	Location:	N
ADA ID: 3DAA6FA7ACAD	Ramp Type: Perp	Initial Pass/Fail: Fail	Overall Compliance: No	Severity Score: 10
Codes/Mitigation Info/Possible Solution		Field Measurements/Component Compliance

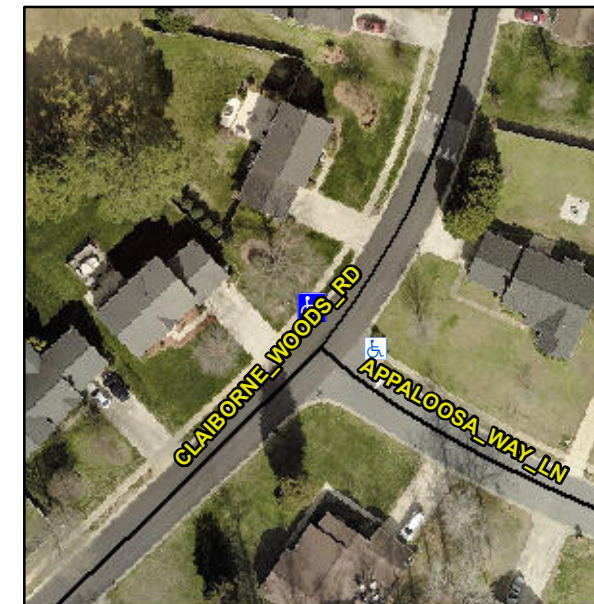
Compliance	Description	Data	Compliance	Description	Data
N/A	Ramp Length (in)	47.0	Yes	Ramp Slope (%)	6.9
No	Ramp Width (in)	47.5	No	Ramp XSlope (%)	2.9
N/A	Flare Type LT	N/A	N/A	Flare Type RT	N/A
N/A	Flare Slope LT (%)	N/A	N/A	Flare Slope RT (%)	N/A
N/A	Flare Traversable LT?	N/A	N/A	Flare Traversable RT?	N/A
N/A	Landing Length (in)	N/A	N/A	DWS Provided?	N/A
N/A	Landing Width (in)	N/A	N/A	DWS Contrast?	N/A
N/A	Landing Slope (%)	N/A	N/A	DWS Length (in)	N/A
N/A	Landing X Slope (%)	N/A	N/A	DWS Full Width?	N/A
N/A	Landing Curb? (Y/N)	N/A	N/A	DWS Offset (in)	N/A
N/A	Shared Landing?	N/A			
N/A	Gutter Ponding?	N/A	N/A	Gutter Slope (%)	N/A
N/A	Gutter Lip Ht (in)	N/A	N/A	Gutter X Slope (%)	N/A
N/A	Painted X Walk1?	No	N/A	Painted X Walk2?	N/A
	X Walk 1 Direction	To SW		X Walk 2 Direction	N/A
N/A	X Walk 1 Width (in)	N/A	N/A	X Walk 2 Width (in)	N/A
	X Walk 1 Slope (%)	2.7		X Walk 2 Slope (%)	N/A
	X Walk 1 X Slope (%)	1.9		X Walk 2 X Slope (%)	N/A

N/A	Ramp inside XWalk1?	N/A	N/A	Ramp inside XWalk2?	N/A
	Road Slope (%)	N/A	N/A	Clear Space?	N/A
	Road X Slope (%)	N/A	N/A	Clear Space to XWalk (in)	N/A
N/A	Any Obstructions?	N/A	N/A	Storm Grate/Utility Hazard?	N/A
	Obstruction Type			Storm Grate/Utility Type	
		N/A			N/A
			Yes	Surface Condition? (G/P)	Good

Possible Solutions:

Remove & Replace Entire Ramp.
